National report of Aruba, Curaçao, Bonaire 1993–2004

by
Gerard van Buurt

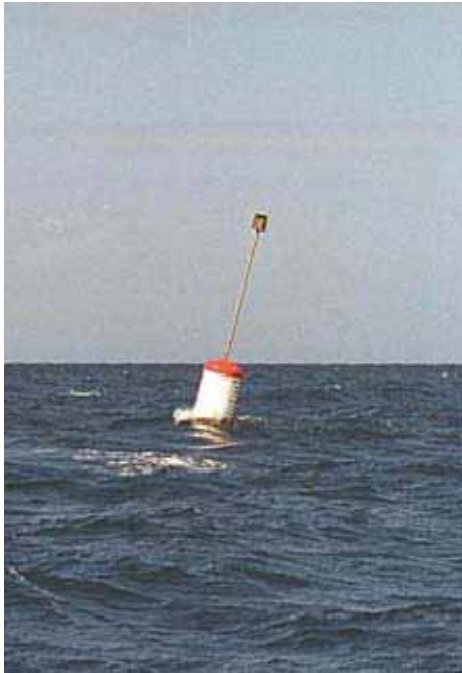
**MKII FAD-GRP3,
700 m mooring depth**

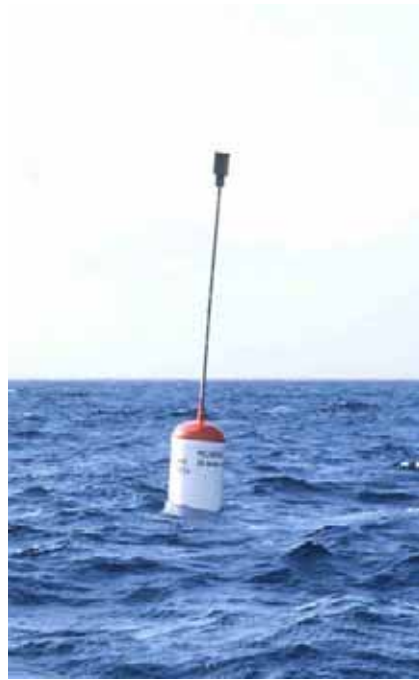
**MKII-GRP7
Medium strength current
560 m mooring depth**

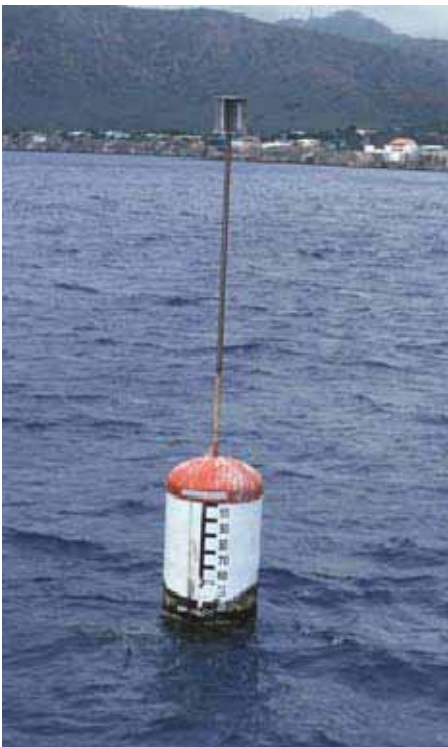
**MKII-GRP8
Weak current
430 m mooring depth
Considerable reserve buoyancy remaining**

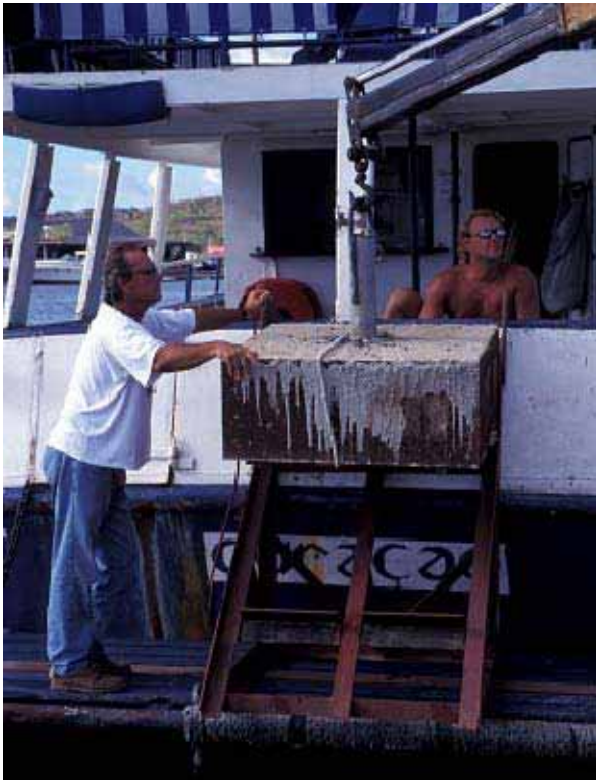
Old type anchor (1 260 kg)
Being lowered on ramp

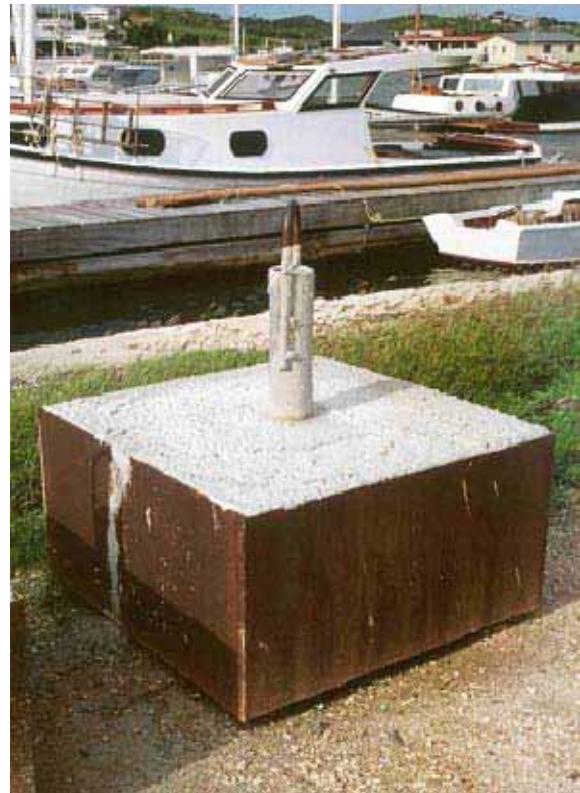
1 500 kg anchor
The weight of the anchor has been
increased from 1 260 kg to approx. 1 500 kg
The underwater weight of the anchor is
approx. 1 000 kg

– The weight of the anchors has now been increased from 1 200 to 1 500 kg. The MKII buoys will not be moored deeper than 600 m, to avoid them being pulled under by the currents, which can be very strong occasionally. This is based on calculations done by Mr Alain Lebeau, IFREMER, assuming a maximum surface current strength of 2.7 knots, which is reduced to 1/3 of its strength at 150 m depth and from there linearly reduced to zero at the bottom. South of Seru, Colorado in Aruba, the currents can be even stronger and may well reach 3 knots or more. Furthermore it seems likely that these currents run all the way to the bottom, without diminishing much in strength (it is reported that this has been observed in a small submarine diving to the bottom at 180 m). As a result even though the mooring depth of FADs around Aruba is much less, plenty of reserve buoyancy and a heavy anchor (1 200–1 500 kg) are still needed. In Aruba a somewhat

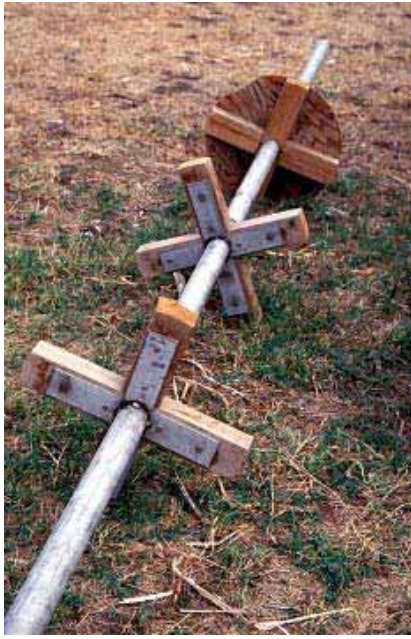
Interior supports of 3 m PVC buoy

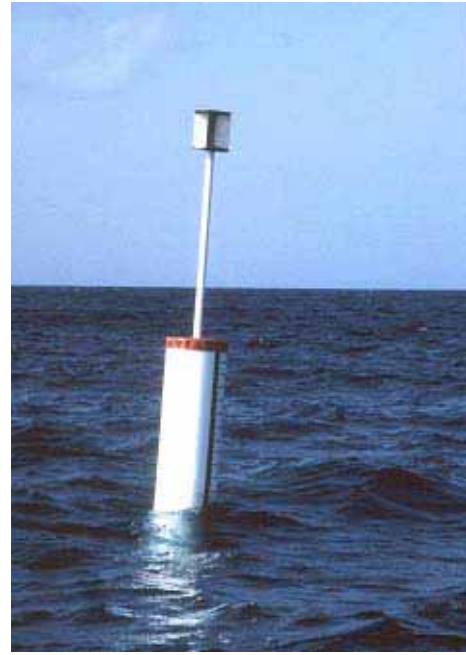
**3 m PVC FAD, PVC 1,
260 m mooring depth**

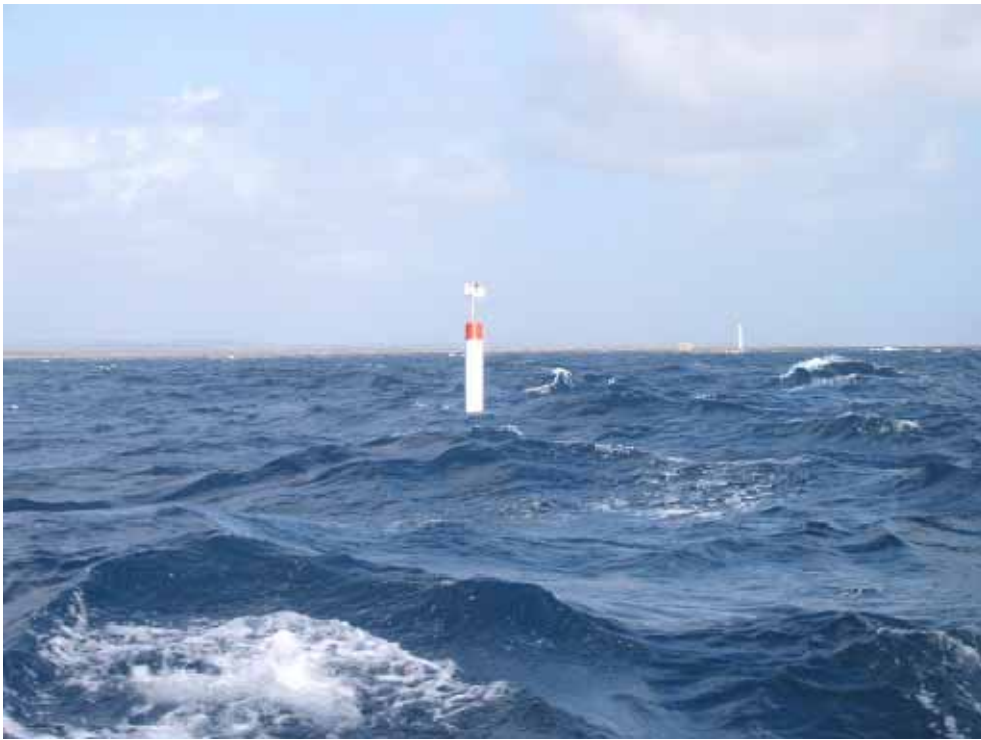
FAD RVS3 at Spelonk, Bonaire, 440 m mooring depth

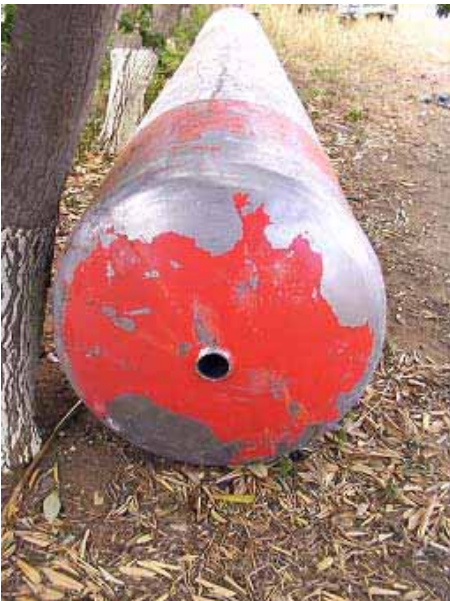
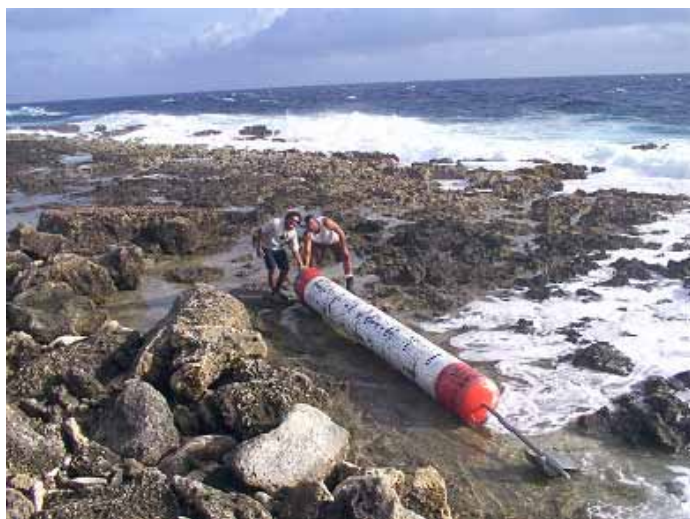
FAD	Model	Cause or probable cause of failure	Mooring depth in meters	Longevity in days	Location exposure to waves and currents
RVS 1		Metal fatigue due to resonance (diameter of mast insufficient)	360	11	Westpunt/ Playa Kalki xx/xxx
RVS 2		idem	530	6	Slagbaai xx/xx
RVS 3		idem	440	4	Spelonk xxxx/xxx
RVS 4		idem	387	5	West of Pink Beach xx/xx
RVS 5		idem	247	8	West of Klein Bonaire x/x
RVS 6	Strengthened	Still in water at time of writing, since 19 July 2002	430		Boca xx/xx
RVS 7	Strengthened	Still in water at time of writing, since 3 December 2002	185		West of Manchebo xx/xx
RVS 8	Strengthened	Anchor probably pulled to deeper water by the very strong currents, in these conditions anchor of approx 900 kg is of insufficient weight	185	approx 2 weeks	West of Malmok xxxx/xxxx
RVS 9	Strengthened	insufficient scope due to error	285	approx 3 weeks	South of Seru Colorado xx/xxxx
RVS 10	Strengthened	Still in water at time of writing, since Febr 21, 2003	200		Port Marie /Dingo x/xx

4 days later, Sic transit gloria mundi

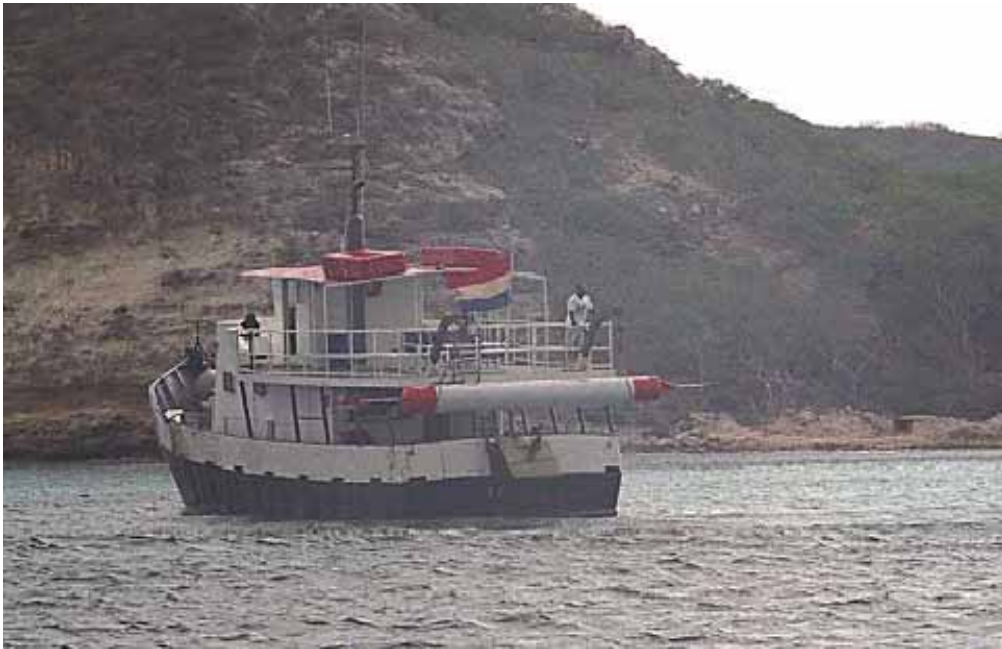
RVS strengthened FAD, RVS 6
Smaller and lighter radar reflector, shortened lower mast with baffles

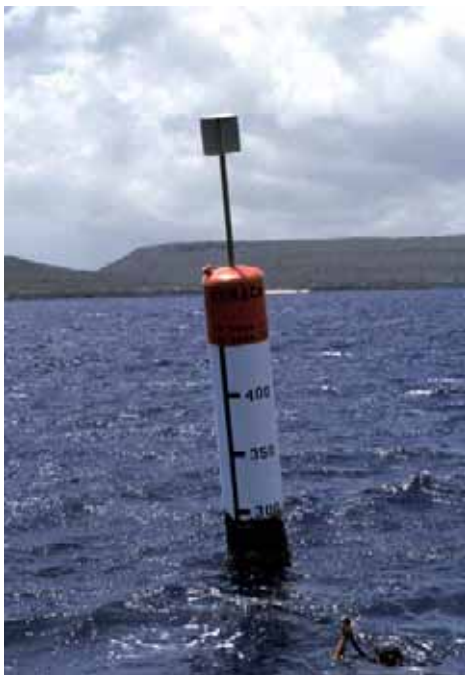
lighter anchor of around 900 kg instead of 1 200 kg was used in view of the much shallower mooring depths, this turns out to have been a mayor mistake, 900 kg being insufficient.

Diver going down to change anodes on SS buoy (RVS 10) on a calm day. This buoy is moored in water of 200 m depth. Note remaining reserve buoyancy. In Aruba an identical buoy moored at 185 m depth dragged its 900 kg anchor and was pulled down by the currents.

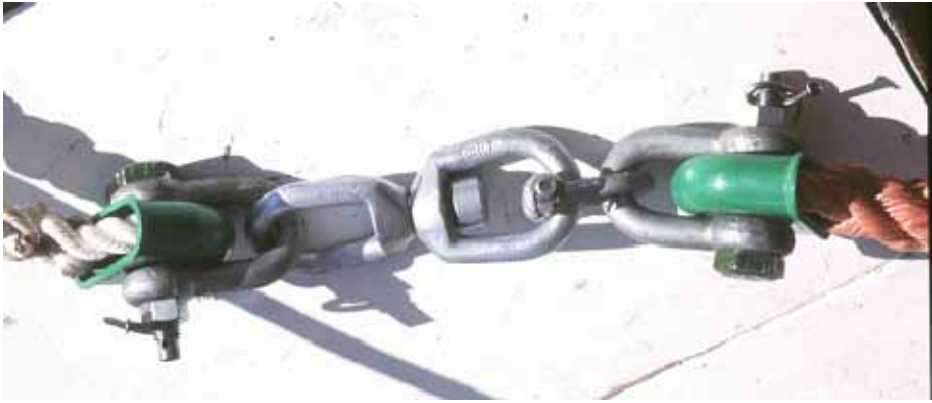
Intermediate swivel with Nylite connectors

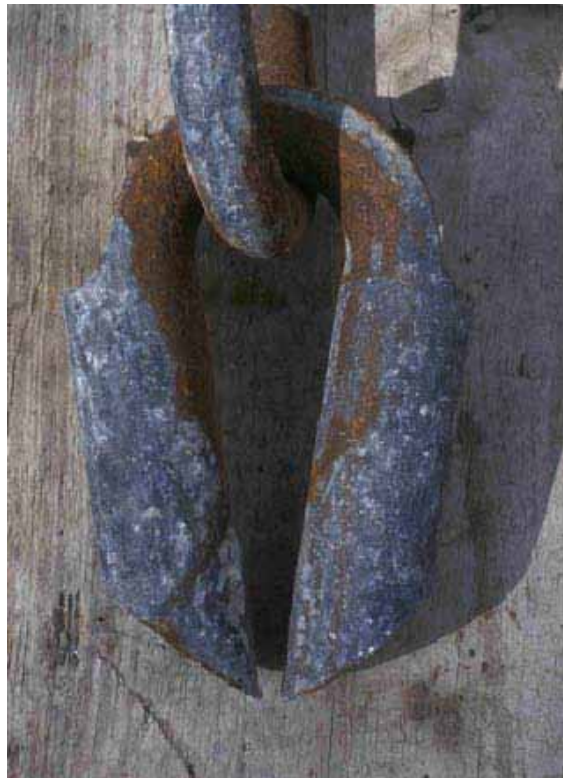
– It is problematic to obtain Nylite connectors. The galvanised connectors used in some of the later buoys are probably not as dependable. A larger diameter galvanised connector has to be used and the rope passed through a plastic hose before passing it through the connector.

Galvanized connector, of inferior quality
