**THE CONSTRUCTION AND DEPLOYMENT OF  
DEEP WATER FISH AGGREGATING DEVICES  
IN THE ISLAND OF CURAÇAO**

GERARD VAN BUURT  
Department of Agriculture, Animal Husbandry and Fisheries,  
Curaçao

RLAC/95/14-PES-25

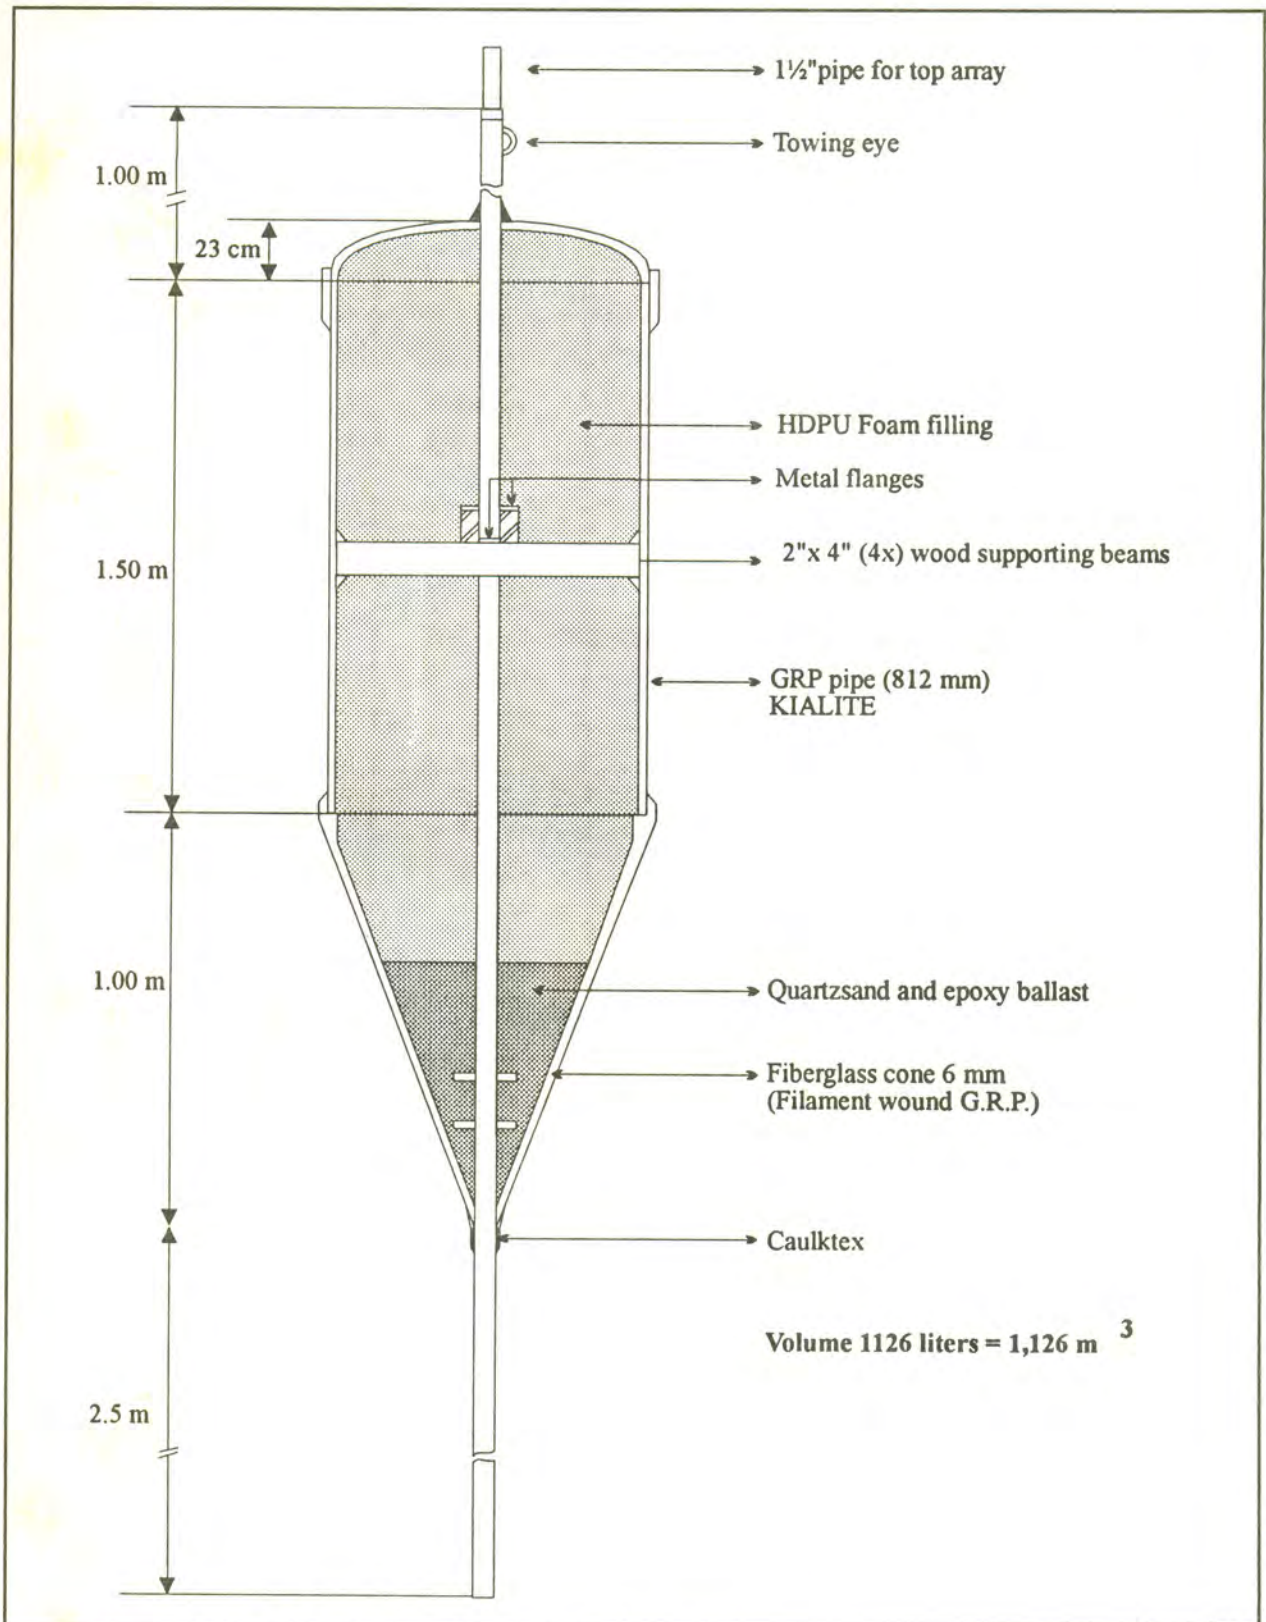
Figure 10 Design for MK 2 buoy; longitudinal cross-section.

On 15 July it was reported that the top light, radar reflector and solar panel on the buoy were missing. A weld in the pipe, which had been made on this buoy in order to change the wire to the battery box, had given way. The remaining stump of the centrepole, protruding about a foot above the top cover, was sealed off with polyurethane foam on 15 July. It was decided to rebuild Buoy No.3, and to start testing features to be used in the improved design (Mark II), incorporating the experience gained. The battery box was transferred to the top of the centrepole and a detachable array of solar panel, radar reflector, battery box and batteries (Figure 11a). The radar reflector was made of 0.8 mm S steel plate (1 kg), instead of 3 mm (9 kg); thus reducing its weight by 8 kg. The fiberglass on this buoy was sanded and an extra layer added to the top cover. The through-buoy passages of the centrepole at the top cover and the nose cone were covered with a flexible compound (Figure 10).

The function of this compound (Caulktex) is to absorb differential rates of expansion and contraction of the GRP and the SS centrepole. Caulktex bonds well to both metal and GRP. On 12 August an attempt was made to change Buoy No.1 with Buoy No.3. The strength of the current was moderate, but waves were fairly high. The lift bag was attached and the buoy with the broken centrepole was released from its mooring. While trying to attach the new buoy, this buoy drifted away against the hull of the M/V *Mermaid*, completely smashing the solar panel and battery box. Subsequently it proved to be impossible to detach the detachable top array. Consequently the old buoy was reattached to the mooring, and the new buoy towed back to the harbour.

The problems that developed with invisible leaks were probably caused by fatigue in the fiberglass; the forces working on the buoys are considerable. Since the buoys had been lying in the sun for a few years before being used, the fiberglass could also have degraded somewhat and weakened by UV solar radiation. The top cover and nose cone should be strengthened and stiffened, and the thickness of the fiberglass should be increased from 3 to 4 layers (from 6 mm to 8 mm), when hand lay-up fiberglass is used, and heavier supporting beams should be used. Special attention should be given to the fastening of the centrepole to the GRP buoy. The difference in expansion rates of GRP materials and steel is large. For this reason a flexible compound has to be used to seal off the through-hull passages of the centrepole.

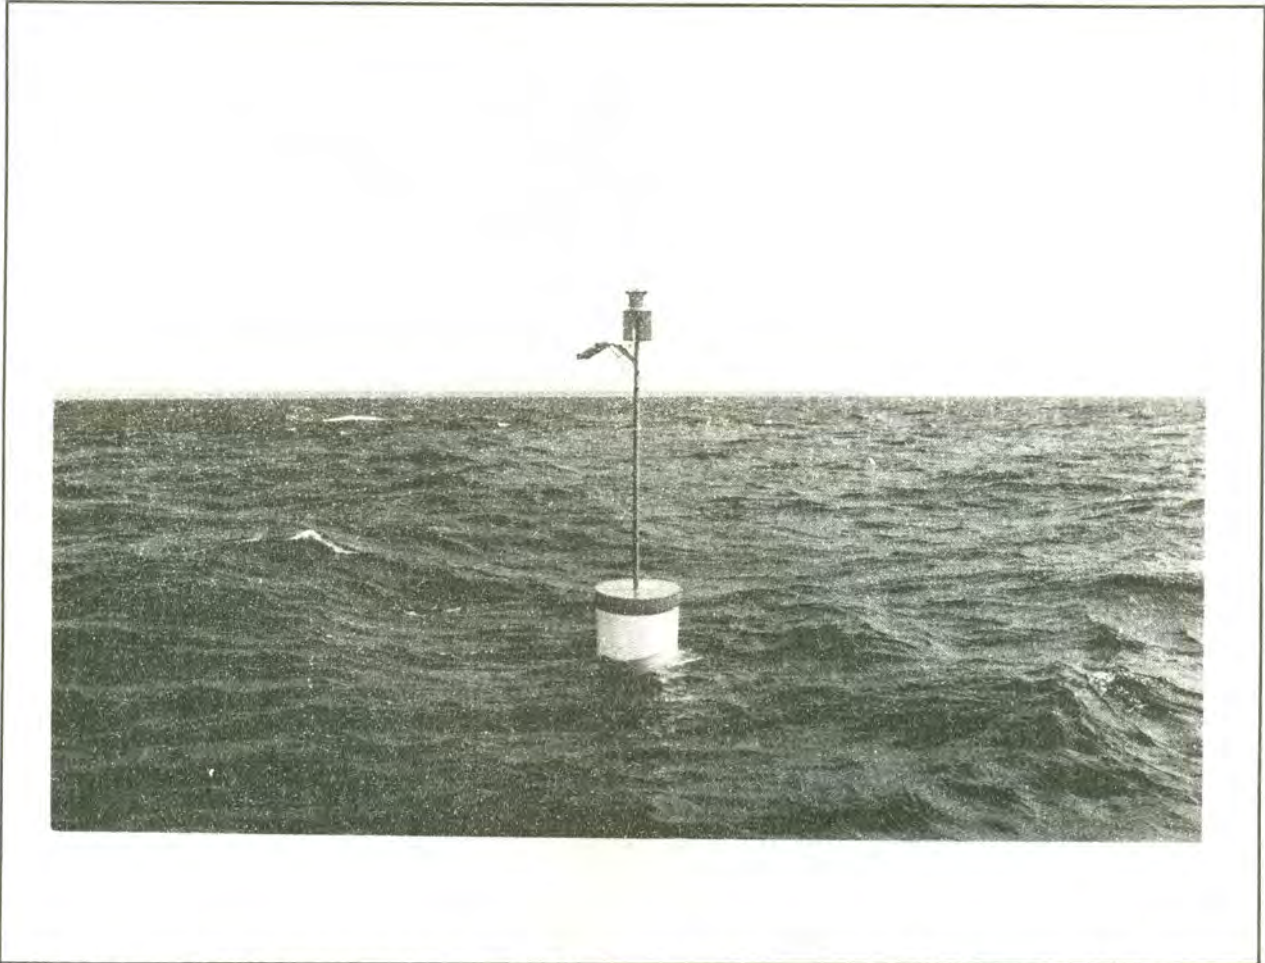
**Figure 20** First buoy in the water, south of Hembraak, at the south-east of Curaçao. Note the first battery cover can be seen; it can also be seen that there is still too much slack in the wiring.

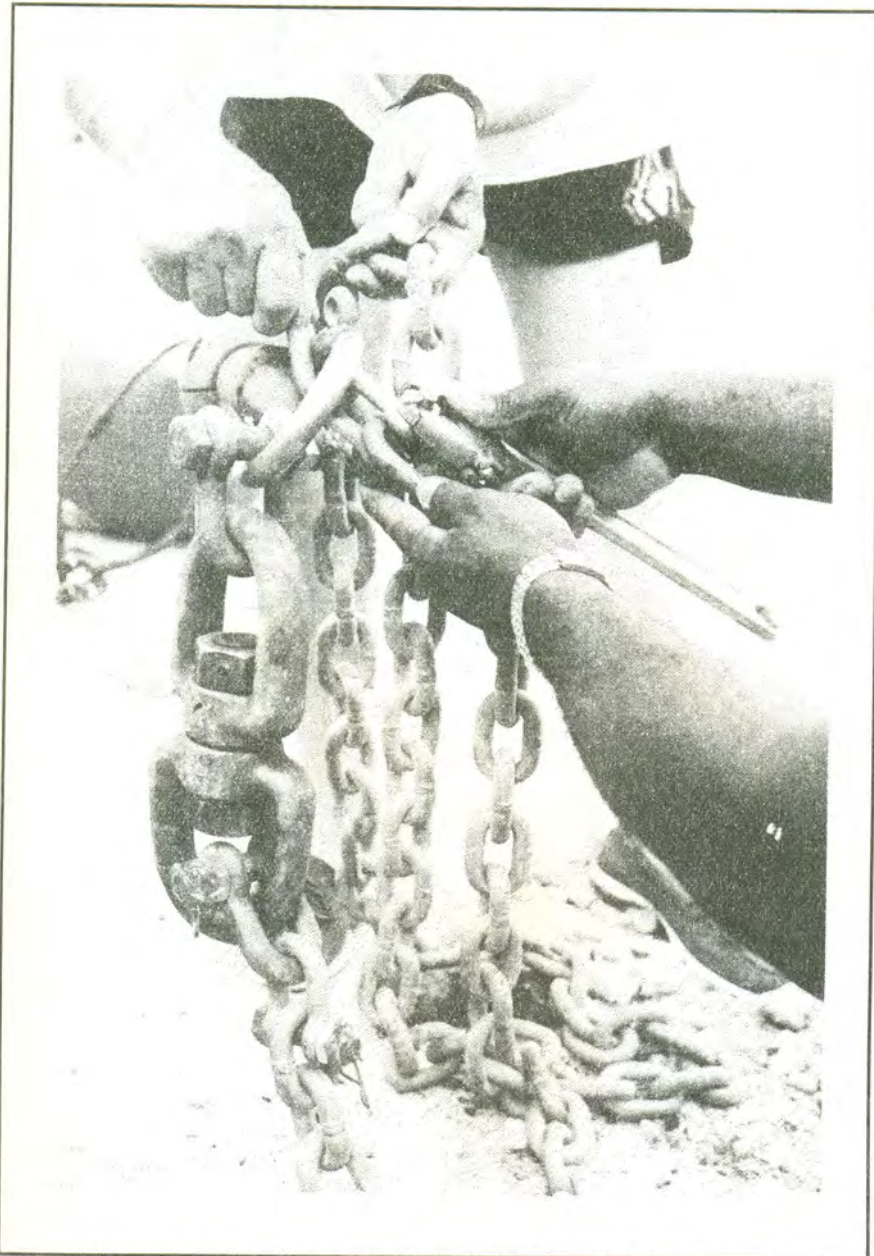
**Figure 21** Chain with swivel and shackles, the sacrificial anode is visible, fastened around the centrepole. The other swivels used further down are smaller.

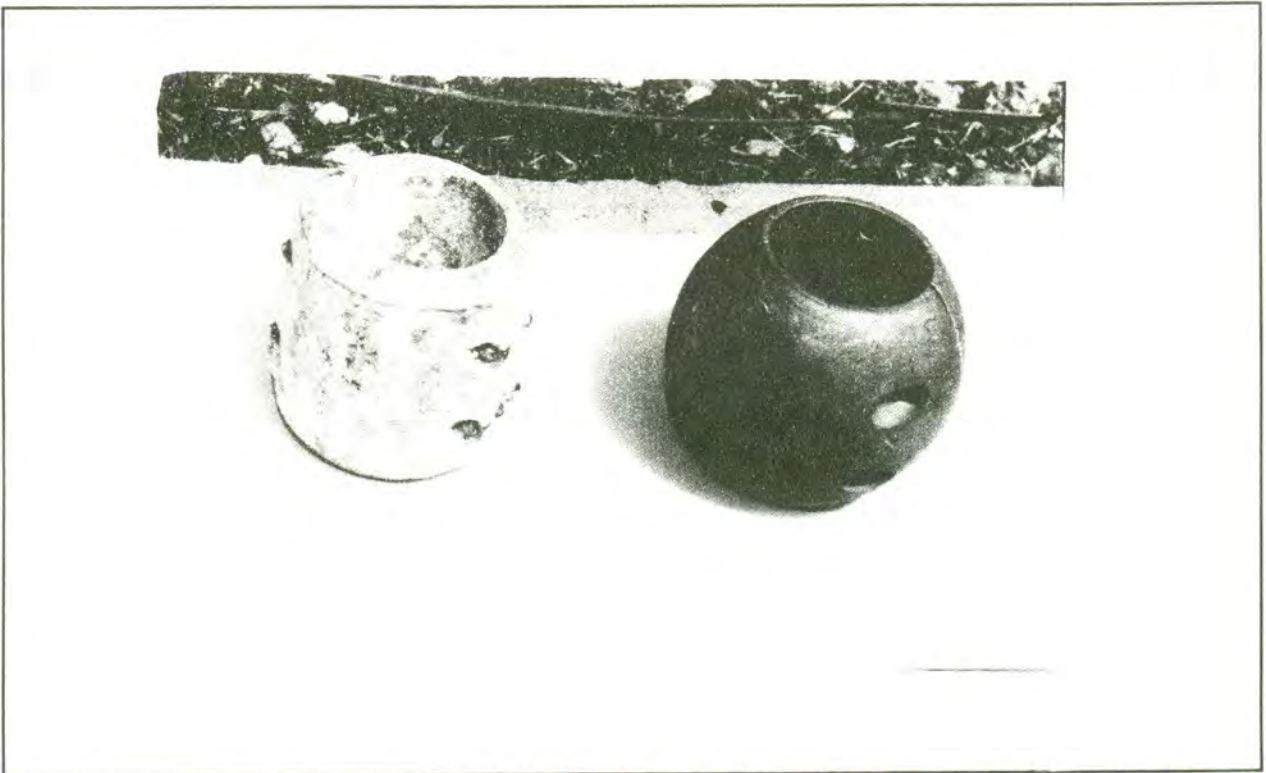
fact remains that it is fairly difficult to change buoys at sea and an accident like this was bound to occur at some point. During a second attempt on 11 November the changing of the buoys was successfully accomplished. The weather was calm and previous mistakes were avoided. The shackles and mooring chain proved to be in very good condition, having been in the water from 21 April to 11 November. The anodes with a weight of 6 kg (2 x 3 kg) on Buoy No.1, which had been in the water from 20 May to 11 November had lost about 1 kg (2 x 0.5 kg) of weight each, over a period of approximately  $5 \frac{3}{4}$  months (approximately 174 g / month).

**Figure 22** The sacrificial anode of the first buoy, 1.5 kg remaining after seven months and ten days of use, in comparison with a new 3-kg sacrificial anode.

The centrepole of the surface buoy was made of stainless steel while the ballast chain was made of galvanized steel; it would have been desirable to avoid the use of dissimilar metals. However, had a galvanized steel pole been used, then the zinc coating would have been lost at the welds and these would then have been exposed to corrosion acting on the areas with greatest stress. It was also noted that the zinc coatings on most pipes commercially available in Curaçao are rather thin. In Curaçao no facilities exist for hot galvanized dip coating. For these reasons the use of a stainless steel centrepole was preferred. Sacrificial anodes were found to solve the corrosion problem effectively. Even

if the centrepole and all the connectors can be obtained of galvanized materials, it is probably advisable to use sacrificial anodes; there will always be some galvanic currents which could be neutralized. A similar situation can be found at the anchor where a steel bridle is welded to a galvanized pipe and connected to galvanized chain and swivel. In deeper waters, however, temperatures and therefore corrosion rates are much lower, and a thicker attachment bridle could be used.

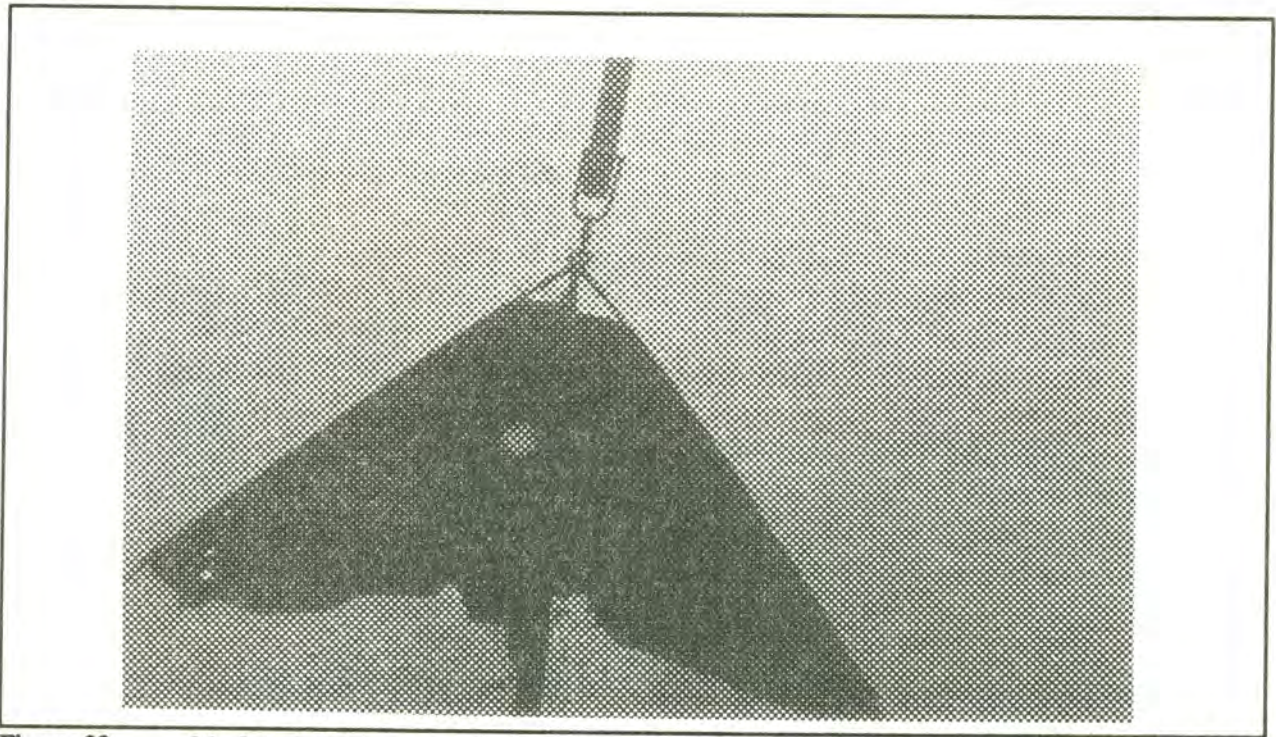
During an inspection trip on 29 April, the underwater appendages were still functioning, but shortly afterward the three MacIntosh attractors were lost, with only the PVC poles on which they had been mounted remaining. The top light stopped burning after about

**Figure 23** MacIntosh fish attractor on second buoy, with stainless steel nose cone attached to end of PVC dampening pole, seen from below.

The MacIntosh underwater fish attractors were designed to provide a sizeable shelter structure while minimizing drag, and in this respect the design is certainly very effective. The problems experienced with these attractors (which were also experienced by Feigenbaum and others) were probably primarily due to their weak construction. Attempts were made to solve this problem by constructing stainless steel nose cones. Secondly, the nose cone of the attractor should not be tied to the mainline. The nose cone eyelet should always be allowed to slide around the line to which it is attached (as indicated in the instructions by MacIntosh). When the attractor cannot be mounted on the mainline, as will be the case in a deepwater FAD using chain below the surface buoy, it should be attached to a separate sideline. The sideline arrangement turned out to be vulnerable to snagging by fishing lines. It was decided to mount the attractors at the end of air-filled PVC dampening poles, using a bridle that allows some movement of the eyelet (Figures 8 and 23). This arrangement was used on the second buoy. In spite of this, all attractors were lost within three weeks' time. A Feigenbaum type attractor which was used on the first buoy was also lost in record time. In Curaçao there are periods when strong currents prevail, the seas are usually quite rough and waves are relatively short and choppy. A more strongly built MacIntosh type attractor, mounted at the end of a dampening pole, could probably do the job. Since these are not available, plastic fibres which are enmeshed in the mooring chain will be used for future FADs.

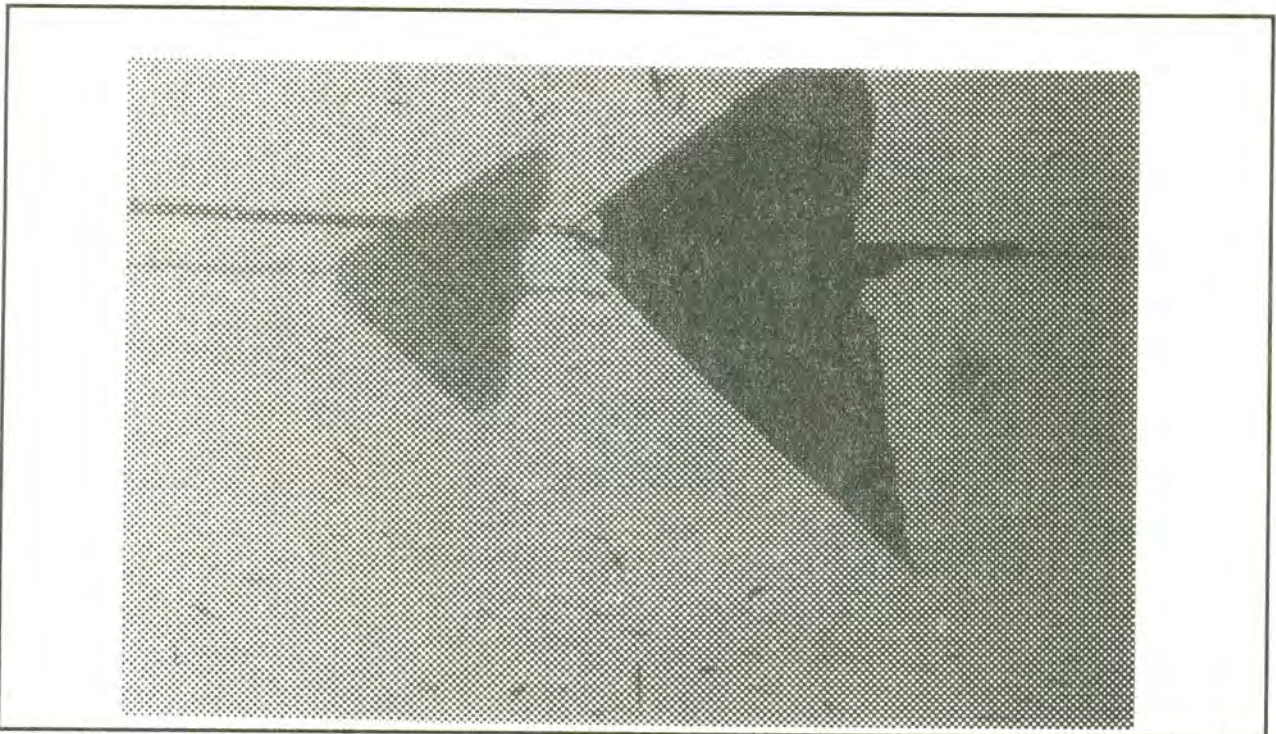
**Figure 24** Two of the three MacIntosh attractors mounted on their respective PVC dampeners. Plenty small baitfish present after only 9 days in the water. Picture taken from below. Left: mooring chain.
