Erosion around Kralendijk, Bonaire

Nick Roos, Master student VU (Vrije Universiteit Amsterdam)

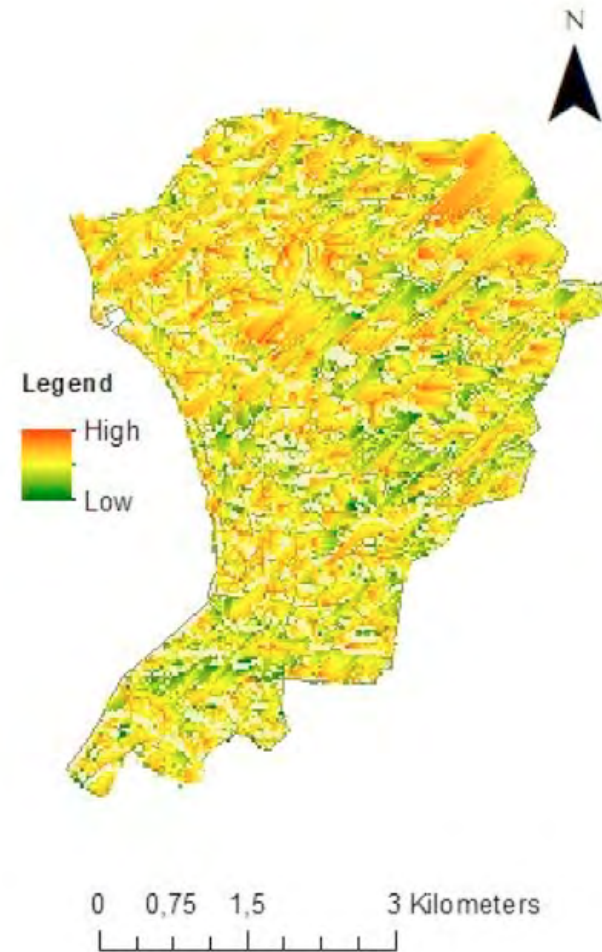
Hotspot erosion map Kralendijk, Bonaire
(Roos, 2018)

The Vrije Universiteit (VU) and Universiteit van Amsterdam (UvA) are teaming up with partners from Bonaire (Wayaká Advies) to do research into these erosion issues. Nick Roos, a MSc Hydrology student at the VU, examined the causes of erosion by determining the most important soil and hydrologic characteristics of different land types around the capital of Kralendijk. In the picture he is measuring how thick the layer of deposited soil is in the Saliña di Vlijt. This appears to be 50 cm in some areas. This is fertile soil that flowed from higher areas into the Saliña during heavy rainfall and is testimony to the magnitude of the erosion issues in the area. Using his measurements, he developed a hotspot map indicating which areas probably constitute most to the erosion.

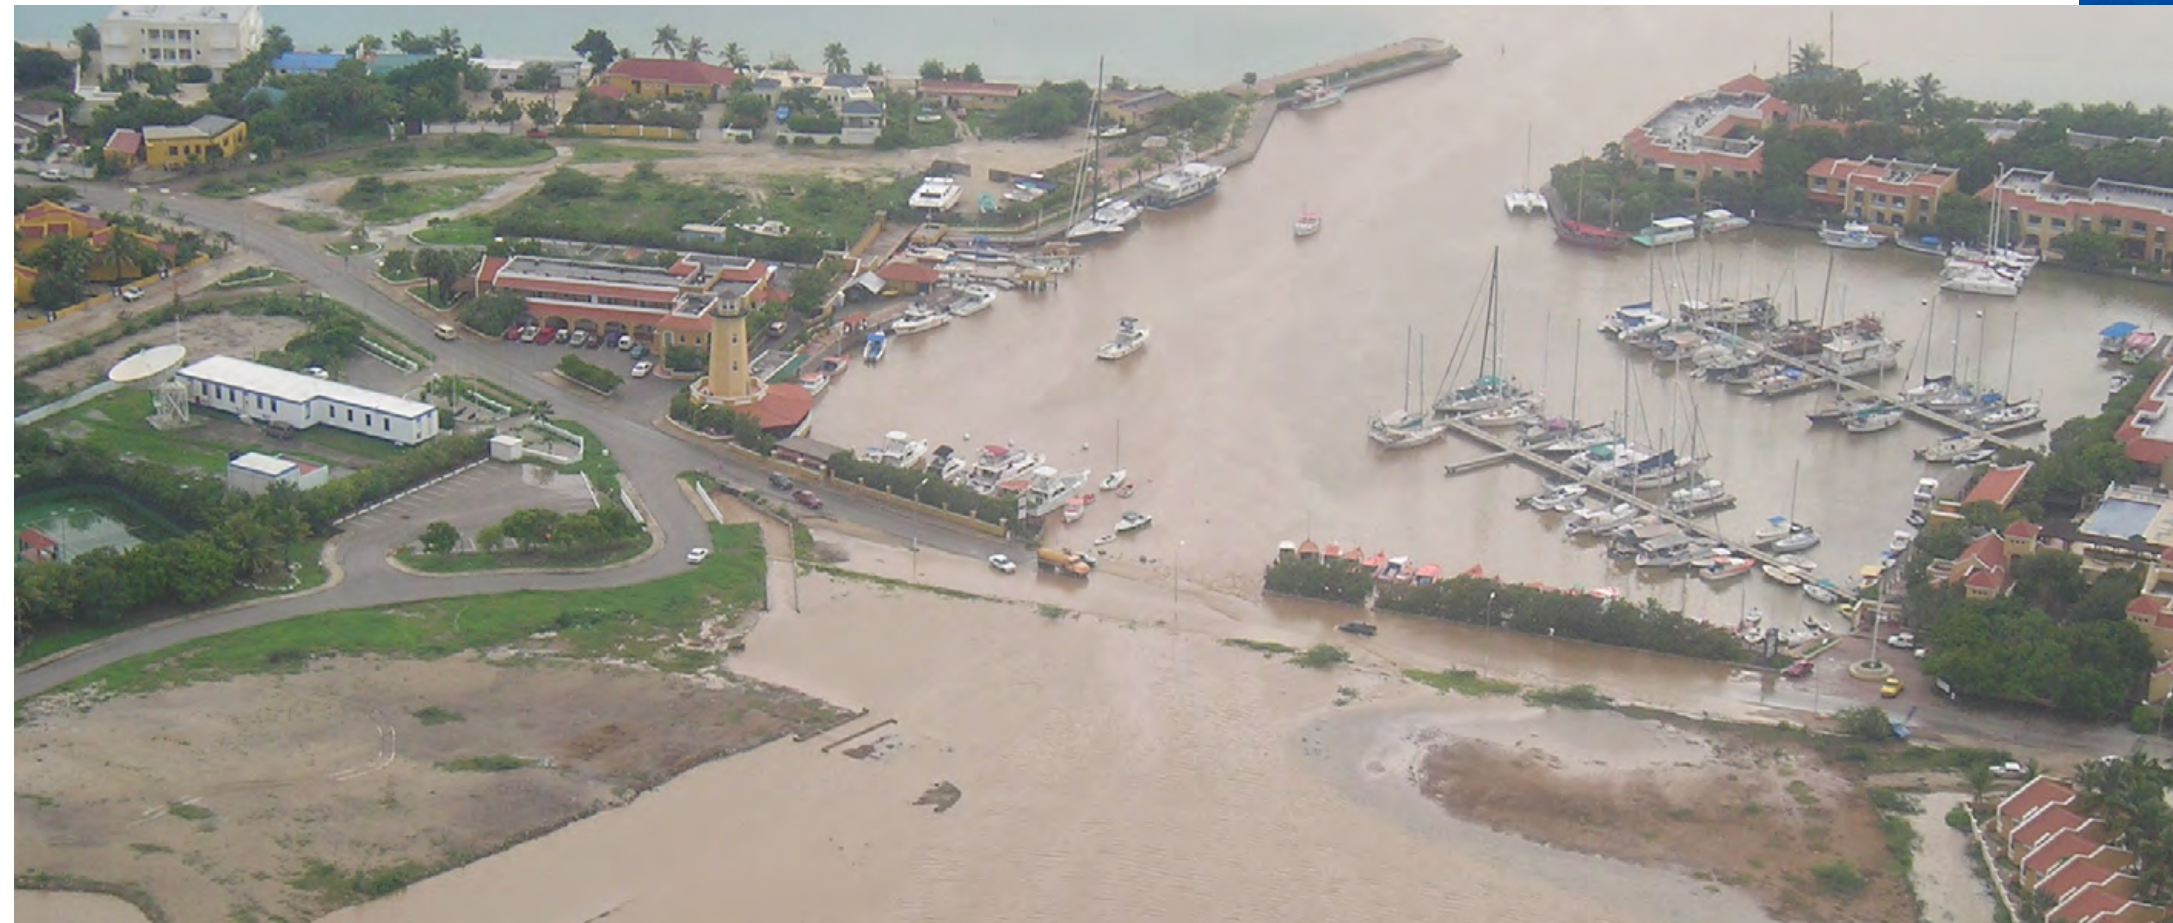
Overflow of Saliñas di Vlijt directly to the sea after heavy rainfall.
