Erosion around Kralendijk, Bonaire

Nick Roos, Master student VU (Vrije Universiteit Amsterdam)

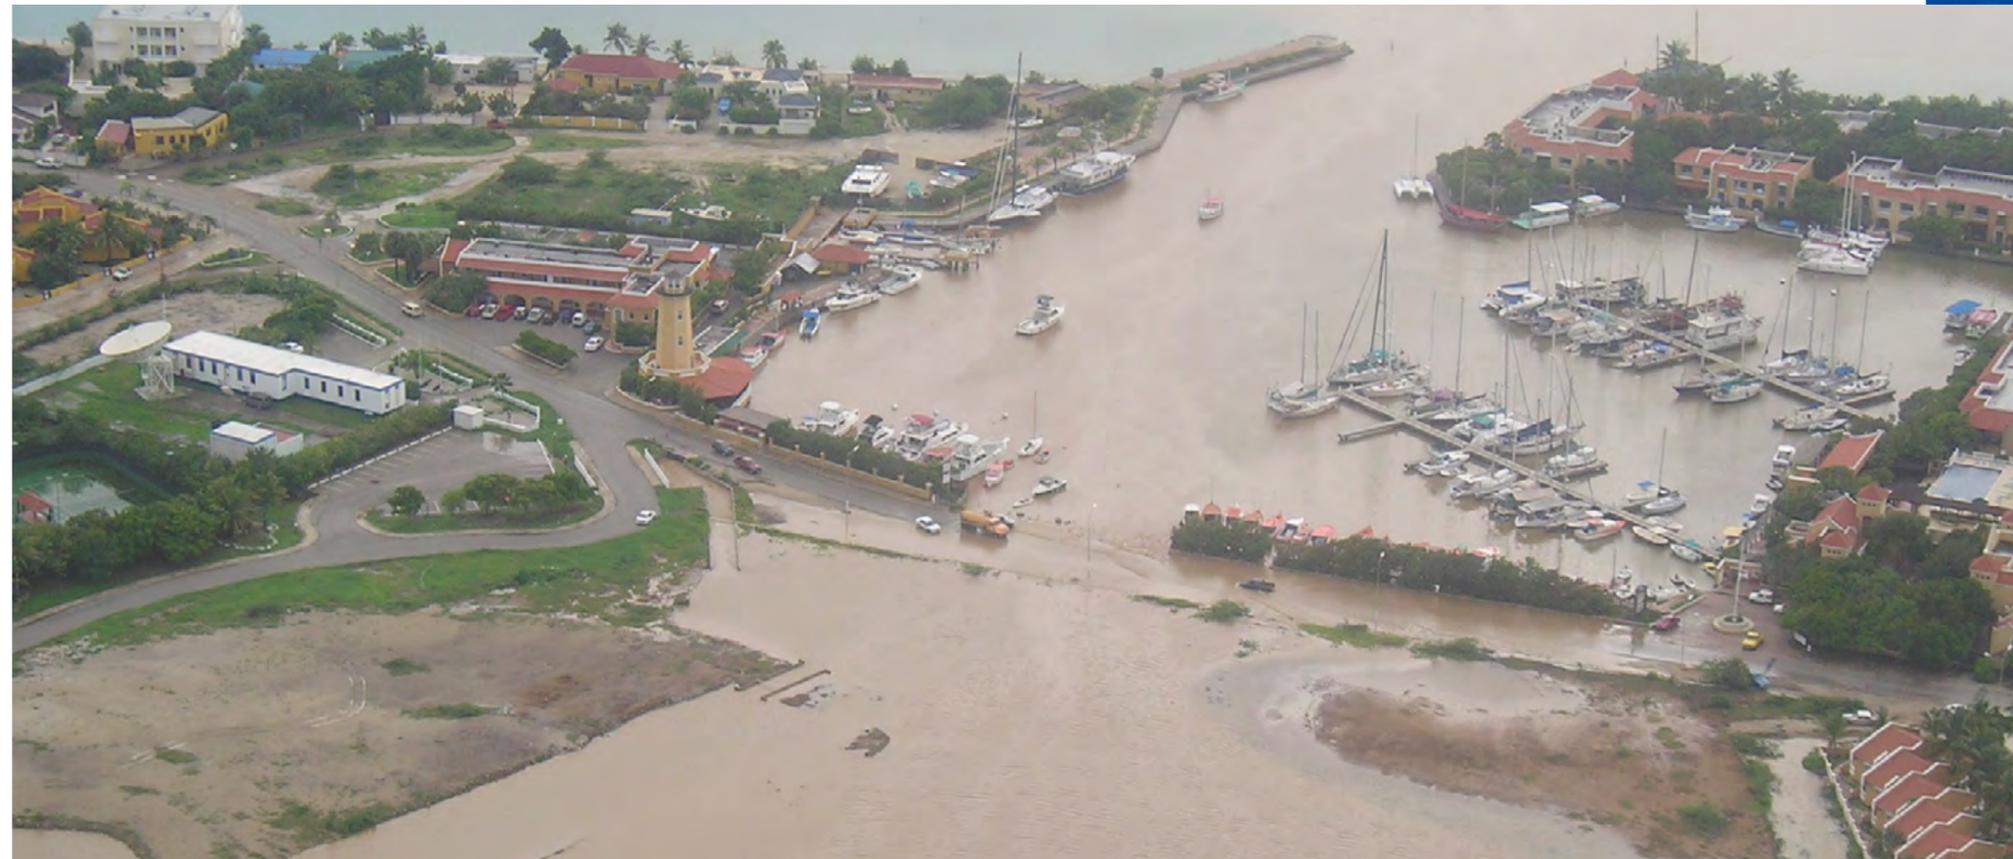
Overflow of Saliñas di Vlijt directly to the sea after heavy rainfall.
