# Eutrophication status of Lac, Bonaire, Dutch Caribbean Including proposals for measures

Report number C093/11

## IMARES Wageningen UR

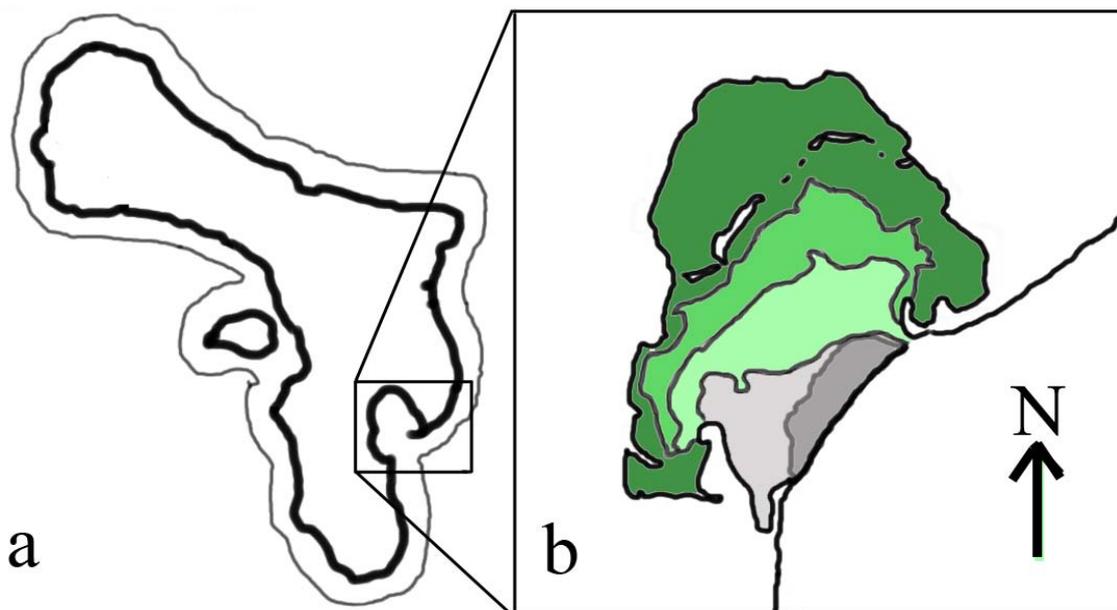
Figure 1. Line drawing of a) Bonaire and b) Lac bay, Dutch Caribbean, indicating major ecotypes. Dark green represents mangroves (past or present), medium green represents shallow seagrass habitat, light green represents deep seagrass habitat, dark grey represents the shallow back reef and coral dam, and light grey represents the sandy depositional area, *Awa blanku*.

Lac is a semi-enclosed lagoon located on the southern-Caribbean island of Bonaire (Figure 1), that experiences mostly diurnal, microtidal Caribbean sea influences with a mean tidal height of about 10 cm (Kjerfve 1981). Although the tidal range can be in excess of 50 cm during spring or neap tides, it rarely exceeds 30 cm and is much lower in the mangrove sub-basins of the bay (van Moorsel and Meijer 1993, Hummelinck en Roos 1969). The reef rim of the lagoon consists of a reef crest along the eastern, outer edge of the bay that limits seawater exchange with the sea. At the northern extent of the rim, the reef crest is scored by a shallow (5 m) channel where it is assumed that most of the water exchange between the Caribbean sea and Lac occurs. Strong tradewinds produce waves on the eastern side of the island of 2 to 3.5 m (van Duyl 1985). The energy of the nearly constantly breaking waves is absorbed by the reef crest and the waters of Lac are relatively calm. There is a wide sand area on the lagoonal side of the reef crest and a back reef that is created by shoreward movement of large carbonate sand grains from the reef crest area. The inner perimeter of the bay is lined with mangroves (*Rhizophora mangle*) and within the bay there are seagrass meadows and a shallow coral reef, the back reef, that lies just inside the reef crest. Lac is the only large lagoon on Bonaire and is exceptional in that it contains a diversity of shallow water coral reef associated habitats in close proximity (mangroves, seagrass beds, *Halimeda* algal beds, the back reef and sand flats) that support a diversity of fish and invertebrates.

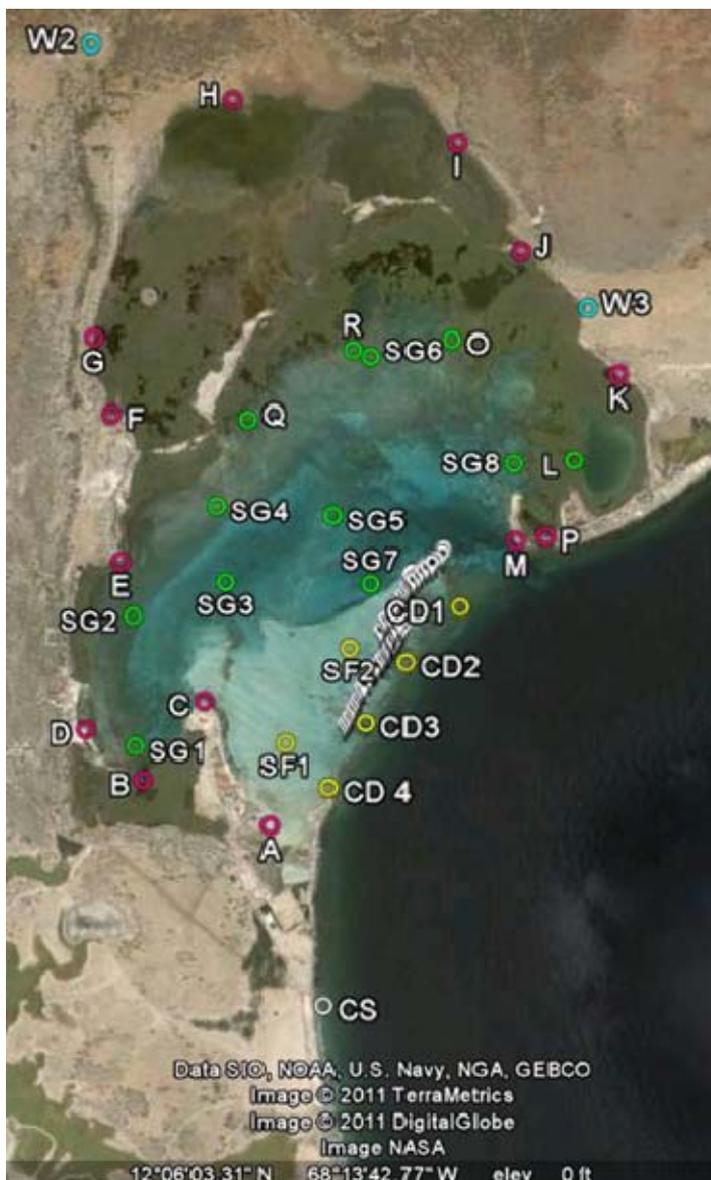
Figure 2. Google Earth image of sampling sites in Lac bay, Bonaire mapped using GIS data collected at the sampling sites. The CD sites represent coral dam sites, SF sites are sand flat habitat, SG sites are seagrass habitat and the remaining sites are mostly mangrove sites. Back bay sites are indicated with pink circles, middle bay sites are represented by green circles and outer bay sites are represented by yellow circles or white balloons. A nearby well (W2) and groundwater sampling site (W3) are indicated by blue circles. CS is a Caribbean sea site used as a control for the bay sites (white circle).

To identify possible areas of eutrophication, 32 sites within the bay and 1 "control site" (CS) that was located 1 km south of the bay were selected for sampling. The sites selected included all major ecotypes and sections of the Lac ecosystem. Sample sites were located in three main areas of Lac: the 18 "back bay" sites were shallow, "shoreline" sites ( $\approx 0.5$  m water depth) that were predominately mangrove habitat with the exceptions of sites A, M and N, which were sandy shoreline sites; the 8 "mid-bay" sites were seagrass habitats (1 to 3 m water depth); and the 6 "outer bay" sites were sand or back reef sites (1 to 2.5 m water depth)(Figure 2). To account for variability in levels of nutrients or bacteria during tidal exchange, water samples were collected on both incoming and outgoing tide for nutrients and bacteria. Additionally, there were two groundwater sites, landward of the bay (W2 and W3), that provided a comparison between groundwater and bay sites.

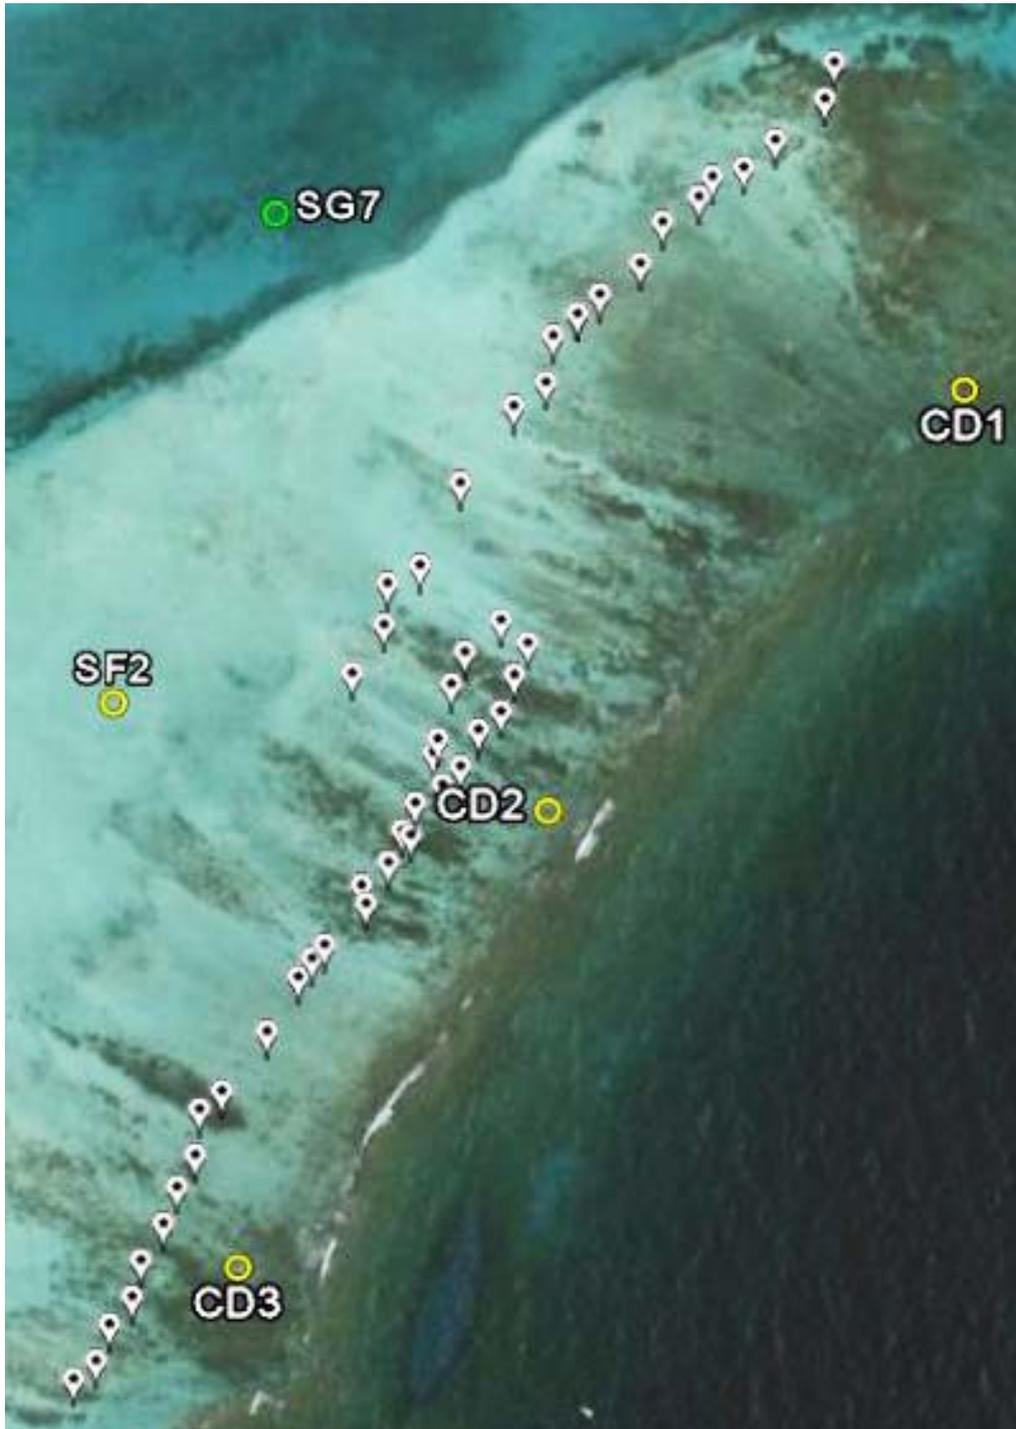
Figure 3. Enlargement of back reef area from Figure 2 indicating the location of fifty 10 m benthic cover line transects (white balloons). Other coral dam (CD), seagrass (SG) and sand flat (SF) sites are included for geographic reference.

The 50 transect stations were approximately 25 m apart and at each station a transect tape was extended in a direction perpendicular to the reef crest (approximately 135° east of north) for a distance of 10 m to measure and categorize the benthic habitat. Benthic composition was measured to the nearest 5 cm along each 10 m transect. Percent cover of the major benthic groupings was plotted to detect areas with high percent cover of *Ramicrusta* sp. or macroalgae, which were not commonly reported in the back reef in the past.

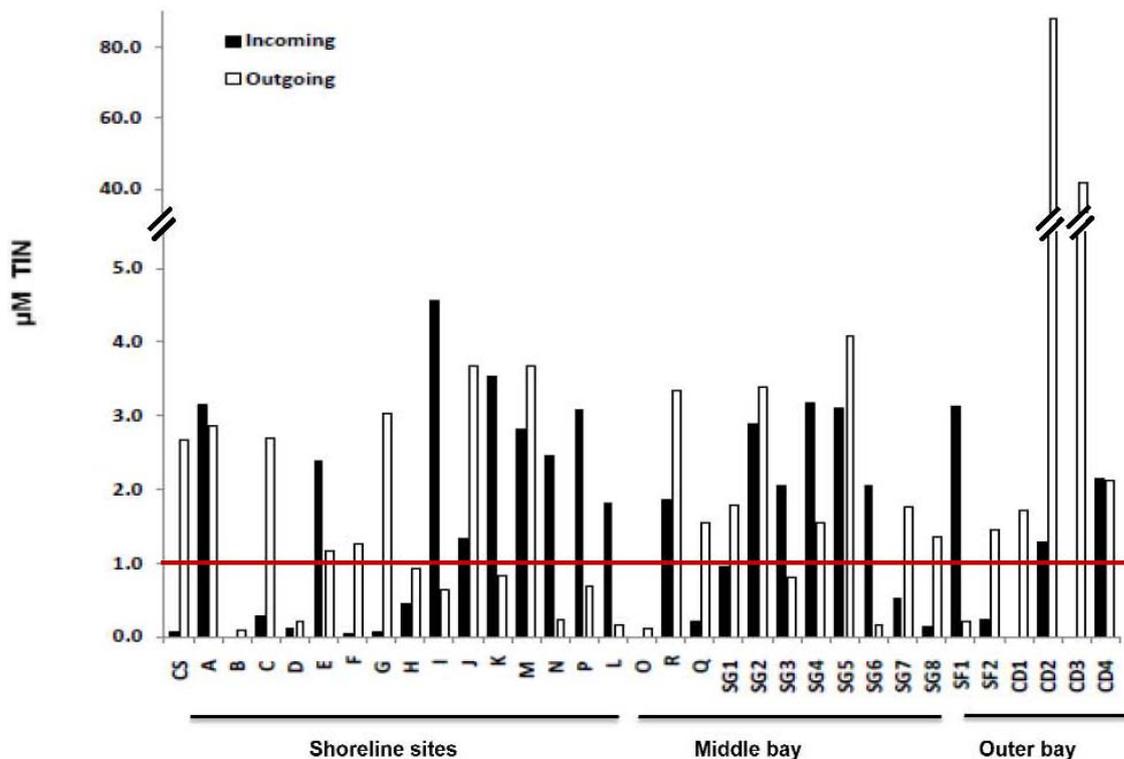
Figure 4. Concentration of TIN ( $\text{NH}_4 + \text{NO}_3 + \text{NO}_2$ ) detected in water samples in Lac bay, Bonaire on incoming and outgoing tides in December, 2010. Red line indicates a threshold for total inorganic nitrogen (TIN) levels on open coral reefs above which reefs are at risk to eutrophication (Bell 1992).

TIN ( $\text{NH}_4 + \text{NO}_3 + \text{NO}_2$ ) concentrations ranged from undetectable ( $<0.05 \mu\text{M}$ ) to  $88.02 \mu\text{M}$ . The mean concentration of all the sites within the bay on the incoming tide ( $n = 32$ ) was  $1.51 \pm 1.36 \mu\text{M}$  and on the outgoing tide the mean was  $5.45 \pm 16.42 \mu\text{M}$  ( $n = 32$ ). The Caribbean sea station (CS) sample values are not included in the calculations of the means for the sites within the bay as that station was selected to provide a comparison with the sea outside the bay. Of 64 samples, 36 (56%) exceeded the acceptable threshold of  $1.0 \mu\text{M}$  for total inorganic nitrogen (TIN) for open coral reef systems (Bell 1992) (Figure 4). When the results are categorized into the 3 major zones (shoreline sites: A,B, C, D, E, F, G, H, I, J, K, M, N, P; middle bay sites: L, O, Q, R, SG 1-8; "outer bay" sites: SF 1-2, CD1-4) the mean TIN levels of incoming and outgoing tides for the shoreline sites, "mid bay" sites and "outer bay" sites all exceed the threshold and the TIN levels during the outgoing tide in the middle bay and outer bay are higher than the incoming tide (Figure 5). The lower levels on the incoming tide may be due to dilution as water from the Caribbean sea moves into the bay. The level of TIN at the CS site was  $0.06$  on the incoming tide and  $2.68 \mu\text{M}$  on the outgoing tide. The higher levels of TIN on the outgoing tide may indicate that the nutrients from the bay were transported to the south of the bay on the outgoing tide.

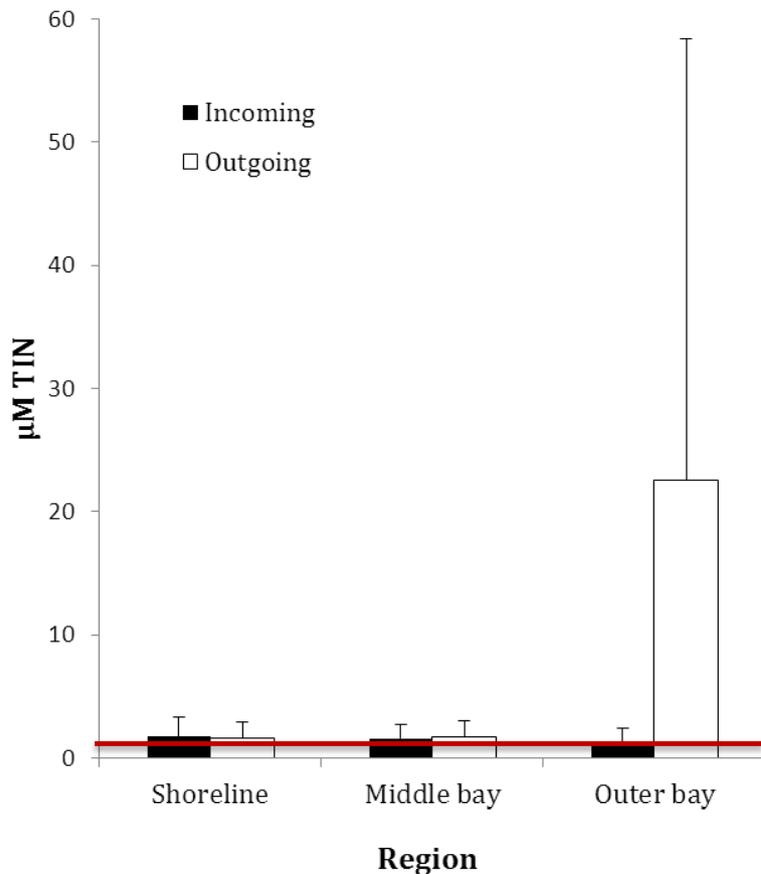
Figure 5. Mean concentration of TIN ( $\pm$  SD) in water samples from Lac bay, Bonaire on incoming and outgoing tides between 22 – 24 December 2010 in 3 regions of the bay; shoreline ( $n=14$ ), middle bay ( $n=12$ ) and outer bay sites ( $n=6$ ). Red line indicates threshold value for TIN for open coastal marine waters.

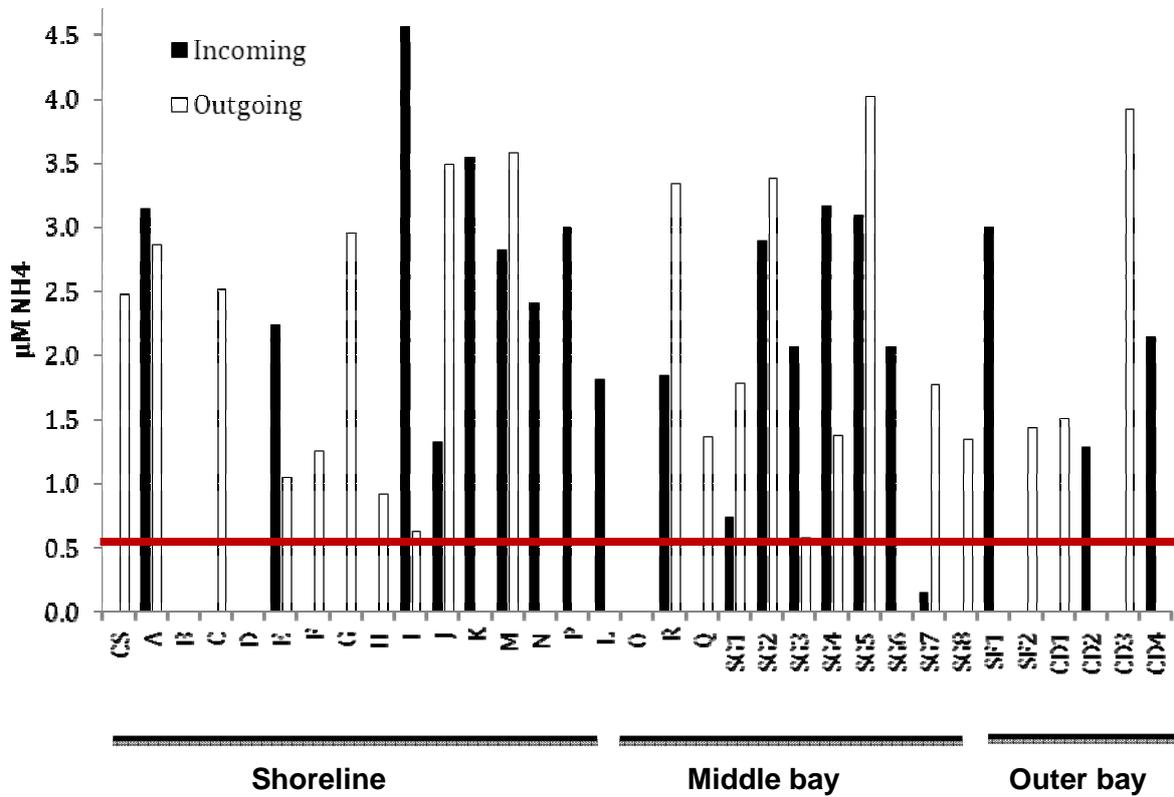
Figure 6. Concentration of  $\text{NH}_4$  detected in water samples in Lac bay, Bonaire on incoming and outgoing tides between 22 - 24 December, 2010. Red line indicates a threshold for total inorganic nitrogen (TIN) levels on open coral reefs above which reefs are at risk to eutrophication (Bell 1992).  $\text{NH}_4$  is a component of TIN.

Levels of ammonia ( $\text{NH}_4$ ) at the 32 sites, on incoming and outgoing tides, ranged from undetectable ( $<0.05 \mu\text{M}$ ) to  $4.56 \mu\text{M}$ , with a mean of  $1.48 \pm 1.41 \mu\text{M}$  on the incoming tide and a mean of  $1.41 \pm 1.37 \mu\text{M}$  on the outgoing tide (Figure 6). Ammonia was the main TIN component in most of the water samples and independently exceeded the limit for TIN in more than 50% of the water samples analyzed from within the bay. The level of  $\text{NH}_4$  at the CS site was non-detectable on the incoming tide and  $2.48 \mu\text{M}$  on the outgoing tide.

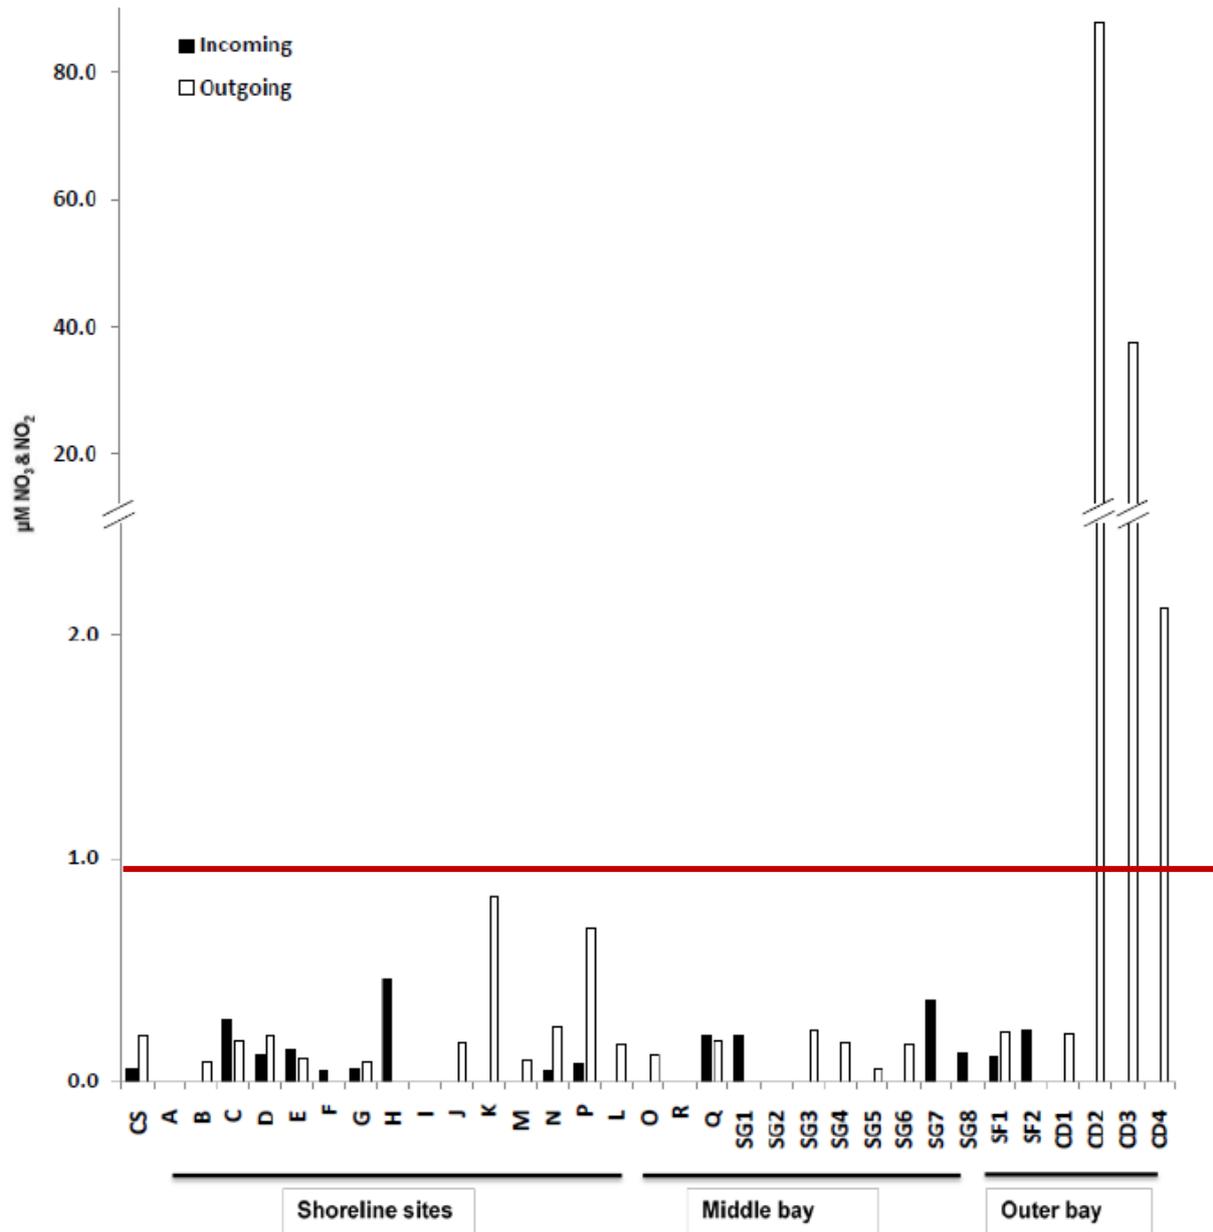
Figure 7. Concentration of  $\text{NO}_3 + \text{NO}_2$  detected in water samples in Lac bay, Bonaire on incoming and outgoing tides in December, 2010. Red line indicates a threshold for total inorganic nitrogen (TIN) levels on open coral reefs above which reefs are at risk to eutrophication (Bell 1992).  $\text{NO}_3 + \text{NO}_2$  are components of TIN.

Concentrations of  $\text{NO}_3 + \text{NO}_2$  ranged from undetectable ( $<0.05 \mu\text{M}$ ) to over  $88.02 \mu\text{M}$ . At three outer bay sites CD2, CD3 and CD4, (during the outgoing tide, levels of  $\text{NO}_3 + \text{NO}_2$  far exceeded the threshold for TIN whereas, levels of  $\text{NO}_3 + \text{NO}_2$  at the other sites in the bay were less than the threshold level on incoming and outgoing tides (Figure 7). The level of  $\text{NO}_3 + \text{NO}_2$  at the CS site was  $0.06 \mu\text{M}$  on the incoming tide and  $0.20 \mu\text{M}$  on the outgoing tide.

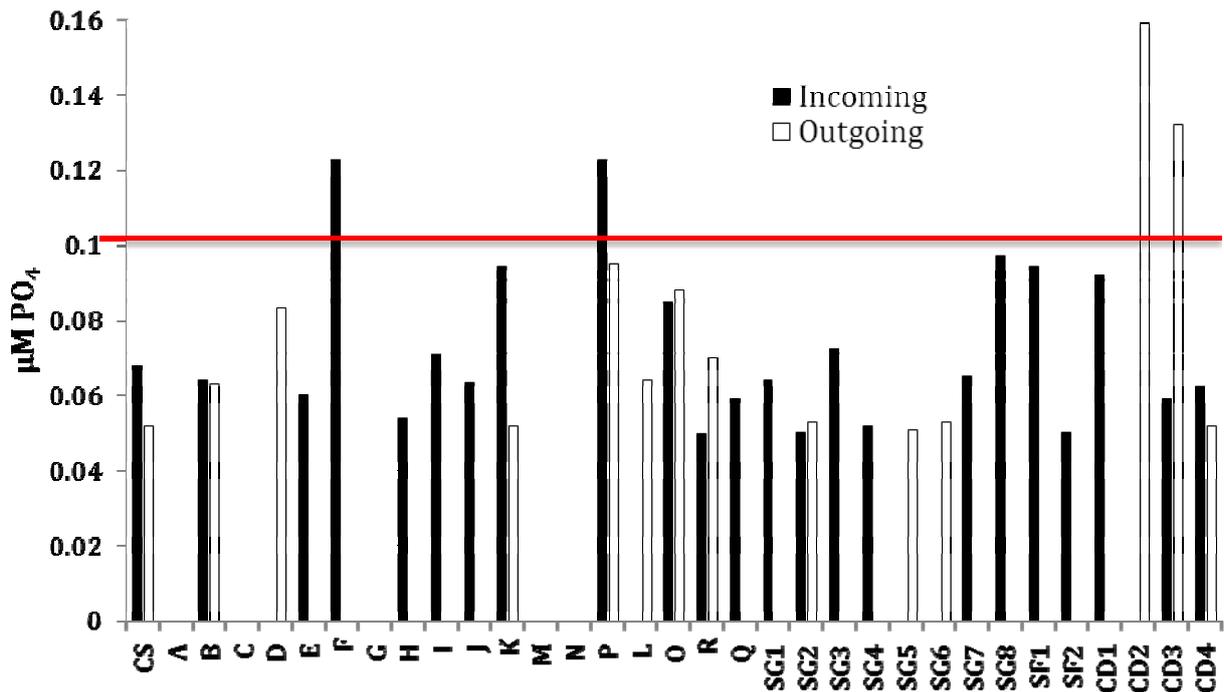
Figure 8. Levels of PO<sub>4</sub> in water samples from Lac bay, Bonaire on incoming and outgoing tides, December 2010. Red line indicates a threshold for levels of PO<sub>4</sub> on open coral reefs above which reefs are at risk to eutrophication (Bell 1992).

Levels of phosphate ( $\text{PO}_4$ ) at 32 sites, on incoming and outgoing tides ranged from undetectable ( $<0.05 \mu\text{M}$ ) to  $0.16 \mu\text{M}$ , with a mean of  $0.05 \pm 0.04 \mu\text{M}$  on the incoming tide ( $n = 32$ ) and a mean of  $0.03 \pm 0.04 \mu\text{M}$  on the outgoing tide ( $n = 32$ ). Of 64 samples, 4 were above the acceptable threshold of  $0.1 \mu\text{M}$  for phosphate for open coral reef systems (Bell 1992) (Figure 8). Two of the 4 samples were taken at the same sites that exceeded the threshold for  $\text{PO}_4$  on the outgoing tide (CD2 and CD3, Figure 8). The other sites that were above the threshold for  $\text{PO}_4$  were shoreline sites, F and P during incoming tide. The level of  $\text{PO}_4$  at the CS site was  $0.06 \mu\text{M}$  on the incoming tide and  $0.05 \mu\text{M}$  on the outgoing tide.

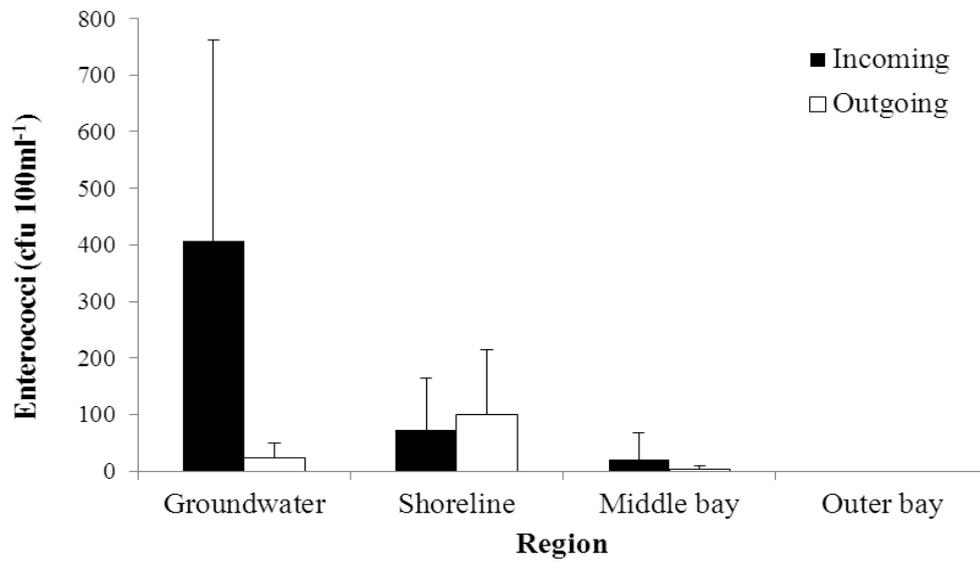
Figure 9. Mean enterococci levels ( $\pm$  SD) in water samples from Lac bay, Bonaire on incoming and outgoing tides, 22-24 December 2010 in groundwater (n=2), shoreline (n=15), middle bay (n=13) and outer bay (n=6) sites.

Eleven of the 64 water samples collected within the bay exceeded ISO Guideline standard for enterococci for marine waters of 100 cfu 100 ml<sup>-1</sup>. Levels of enterococci at marine sites, on incoming and outgoing tides, ranged from undetectable to 399 cfu 100 ml<sup>-1</sup>, with a mean for bay stations of 39.5 ± 0.04 cfu 100 ml<sup>-1</sup> on the incoming tide (n = 32) and a mean of 45.1 ± 90.1 cfu 100 ml<sup>-1</sup> on the outgoing tide (n = 32). For the 2 well sites that are just inland of the bay (15 – 600 m), enterococci ranged from 3.1 to 658.6 cfu 100 ml<sup>-1</sup>, which is well within the range of enterococci detected in the well water of Bonaire, which in recent testing exceeded 2,400 cfu 100 ml<sup>-1</sup> (R Peachey, unpublished data). In this study, the mean levels of enterococci decrease as the distance from shore increases with the highest levels found at groundwater sites and zero enterococci found on the back reef sites (Figure 9). The highest levels of enterococci are found on the shoreline locations along the northern mangrove area, as can be seen in Figure 10, in which enterococci concentrations during outgoing tide are modeled. In appendix 3 an overview of concentration

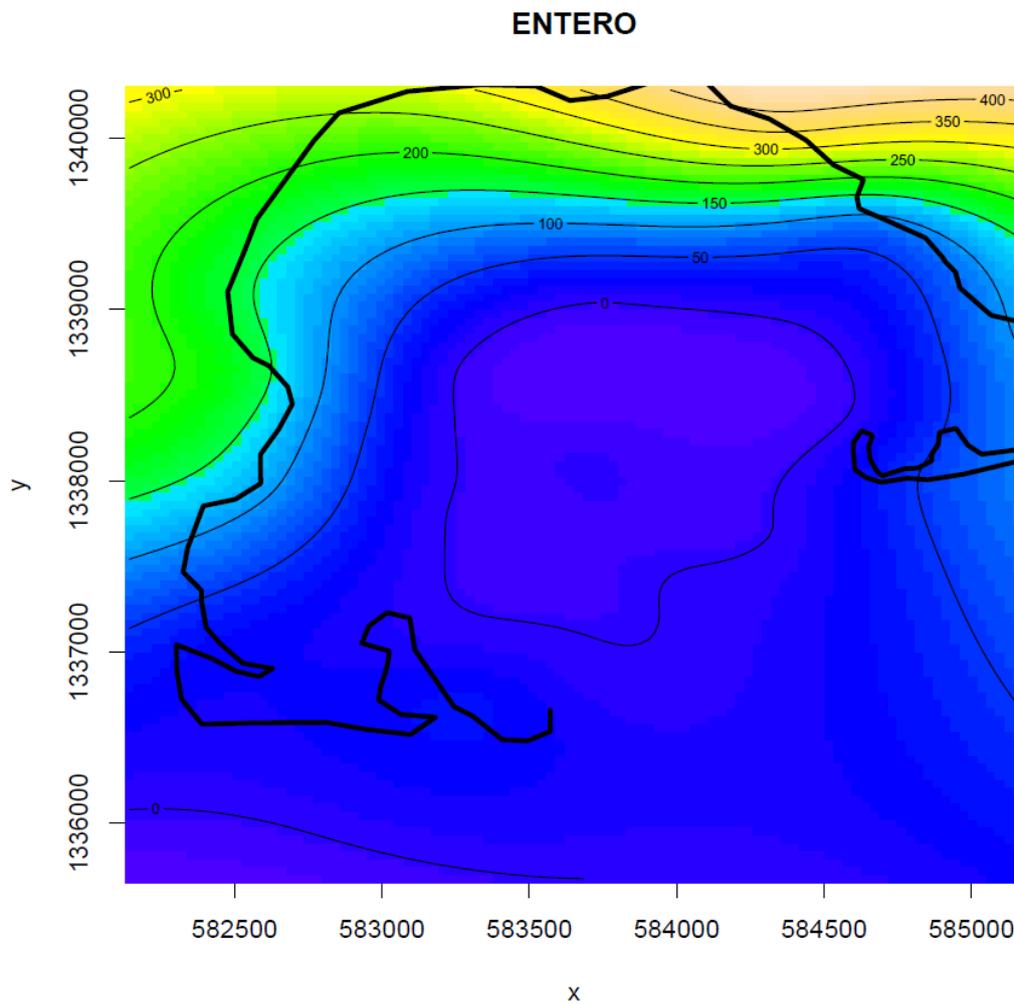
Figure 10 Enterococci data modelled. Based on data obtained during outgoing tide in December 2010.

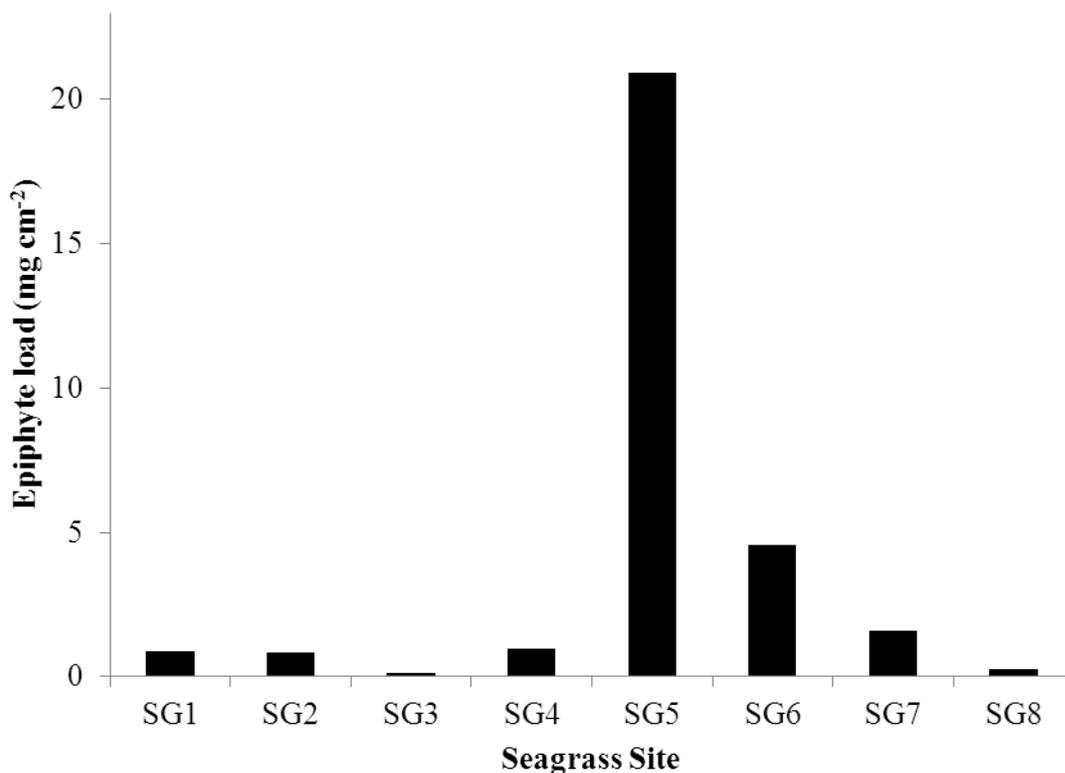
Figure 11. Epiphyte load in dry weight of epiphytes cm<sup>-2</sup> seagrass blade surface area from 8 sites in the middle bay region of Lac bay, Bonaire in December 2010.

Epiphyte loads ranged from 0.1 mg cm<sup>-2</sup> to 20.9 mg cm<sup>-2</sup>. The seagrass station with the highest epiphyte load was SG5 and SG6 had the second highest level (Figure 11). There is no discernable pattern of epiphyte load in the bay with sampling at the scale chosen for this study with sites ranging from 0.5 to 1.0 km apart. Although numerous studies show that algal epiphytes respond strongly to water column nutrient enrichment and that the increases in epiphytes on seagrasses are localized (see review in Hughes et al. 2004); no clear relationship between nutrients and epiphyte load was observed in this study. Since increases in epiphytes are localized around nutrient sources, perhaps SG5 is a hotspot that is worth further investigation. An interesting note is that the water depth at SG5 is over 3 m and it is located in the central deeper region of the bay, in fairly close proximity to the channel. It may be possible that there is some sort of hydrodynamic effect on epiphyte load in this location possibly due to high flow rates in the area that would decrease the boundary layer around the epiphytes, delivering more nutrients, or it could be possible that there is some stagnation (or pooling) in the deepest part of the bay where nutrients could build up due to reduced dilution effects from the sea.

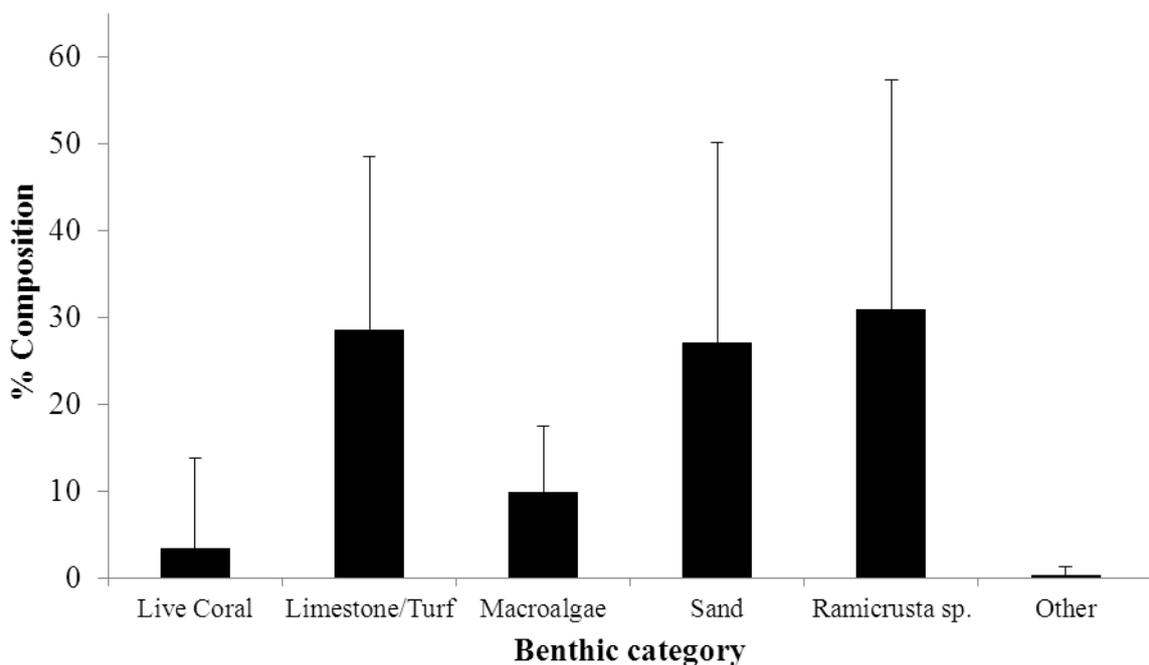
Figure 12. Mean percent composition ( $\pm$  SD) of benthic cover in the back reef habitat of Lac bay, Bonaire in January 2011. Means are the result of analyzing fifty 10 m line transects.

The analysis of the benthic composition on the back reef habitat (n = 50) indicated that *Ramicrusta* sp. (31%), Dead Coral/Turf (29%) and Sand (27%) were the dominant benthic cover types, followed by Macroalgae (10%) and Live coral (3%)(Figure 12). When the categories of Macroalgae and the encrusting alga, *Ramicrusta* sp. are combined the mean percent cover of algae is more than 40% of the substrate on the back reef. The Dead Coral/Turf category is also covered in a thin layer of algae, called

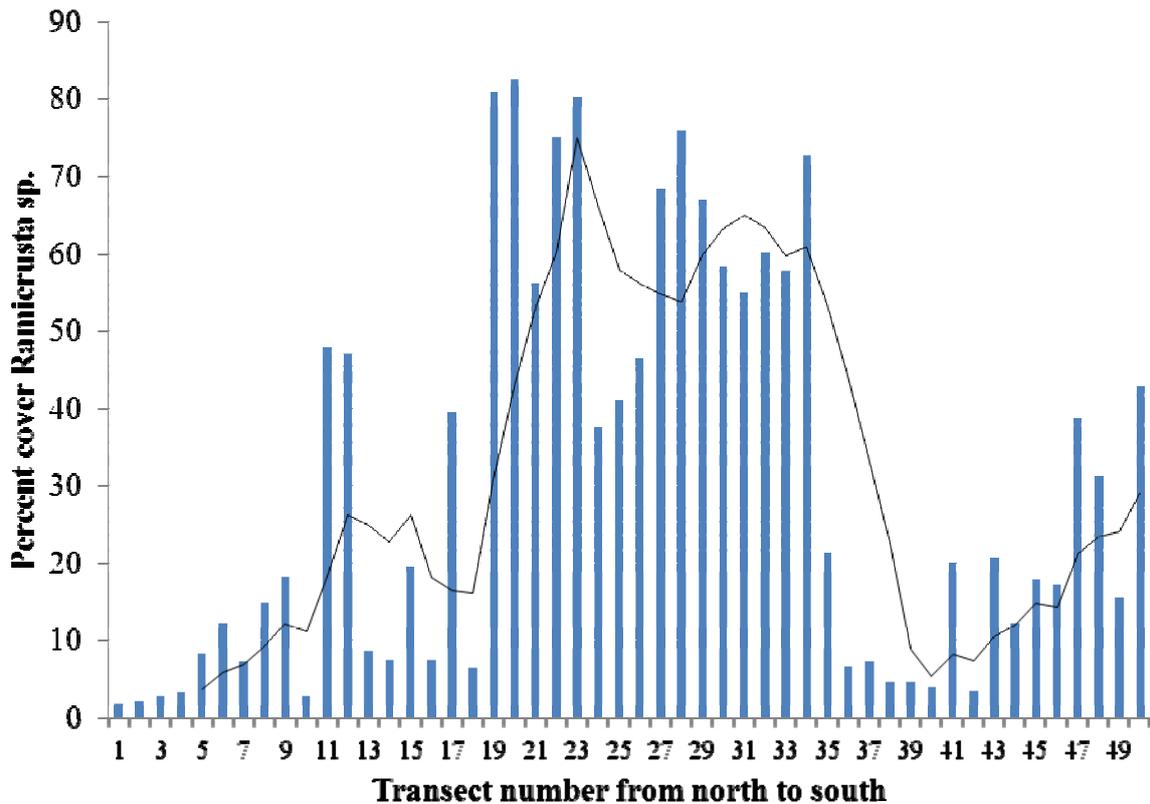
Figure 13. Percent cover of *Ramicrusta* sp. for each transect that was surveyed in order from the north end of the back reef habitat to the southern extent. Surveys were conducted in Lac bay, Bonaire in January 2011.

The percent cover of *Ramicrusta* sp. was plotted for each transect in geographical order from north to south. *Ramicrusta* sp. was present at all sites with a range of 1.9 to 82.7 percent cover and there is a distinct increase in percent cover of *Ramicrusta* sp. in the central portion of the back reef (Figure 13). Additionally, the mean of 5 adjacent transects are plotted as a moving average, the north end of the back reef environment near the channel has the lowest moving average of the habitat (4%); the moving average of the northern reach peaked at about 25% whereas, in the central region, the moving average approaches 75%, and drops off in the southern reach of the bay. However, rather than dropping off like it does in the north, the moving average drops to nearly 10% then increases to 30% in the southernmost reach of the bay where circulation is limited.

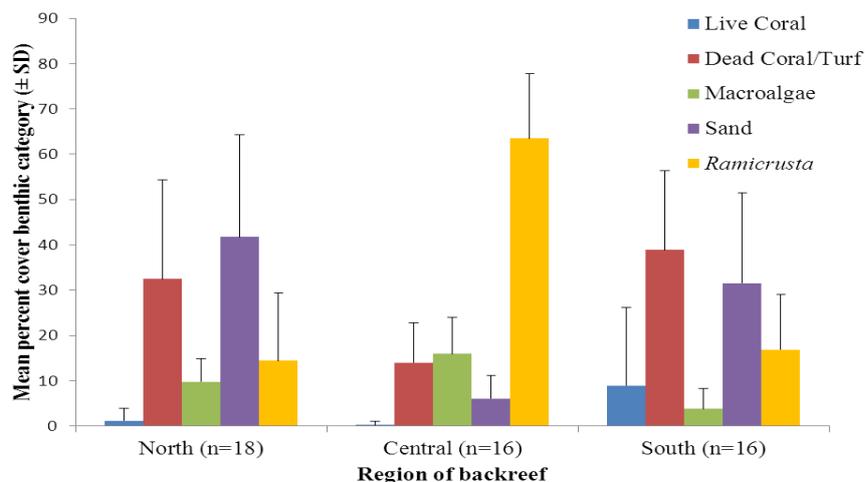
Figure 14. Spatial analysis of mean percent cover ( $\pm$  SD) of benthic groups on the back reef of Bonaire in January 2011 by region of the back reef habitat. The category Other is not shown because the mean is  $< 1\%$  in all regions.

Since there was a distinct pattern within the back reef habitat from north to south, the percent cover by the different benthic groups was determined for the 3 regions. The central region had the highest percent cover of *Ramicrusta* sp. and macroalgae and the lowest percent cover of live coral (Figure 14). The percent cover of Sand was 3 times higher in the northern and southern reaches of the back reef than the central region. An analysis of benthic cover, excluding Sand, where algae cannot attach and grow, shows that the percent cover of *Ramicrusta* sp. of each transect ranged from 5 to 89% along the back reef, specifically on substratum where algae can grow (data not shown). The mean percent cover of *Ramicrusta* sp. is similar in the northern and southern regions of the back reef and is 2.8 times higher in the Central region and Live Coral cover is negligible (Figure 15). The percent cover of the Other category was less than 1% and is not shown in the figure. The pattern of mean percent cover of Dead Coral/Turf Algae is the inverse of the pattern for *Ramicrusta* sp. It is important to note that there is a lot of substratum available for *Ramicrusta* sp. or coral recruitment in the northern and southern regions of the back reef. The only information regarding the benthic composition are lists of coral species said to be common there but no data, either qualitative or quantitative, to compare with the results of this study.

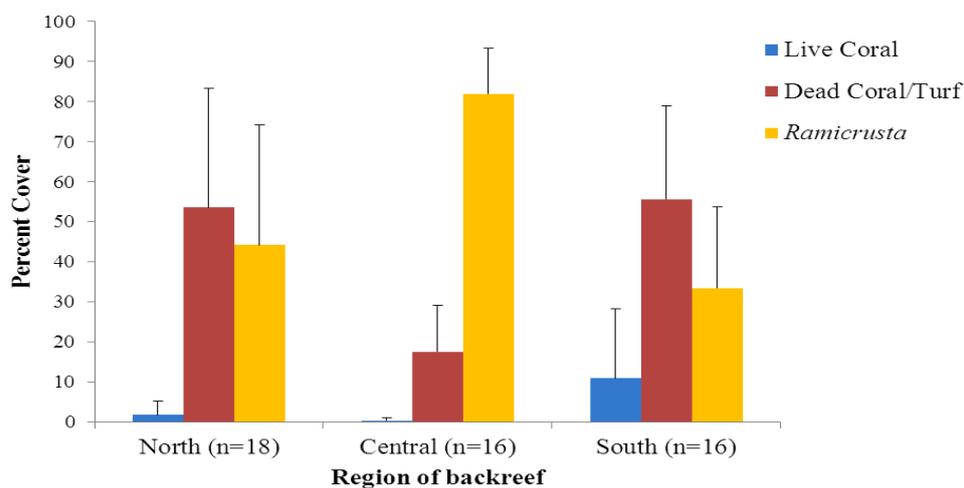
Figure 15. Spatial analysis of mean percent cover of benthic categories ( $\pm$  SD) in line transects conducted in the back reef habitat of Lac bay, Bonaire in December 2010. The back reef is divided into 3 regions north, central and south for this analysis and only substrata that are available for colonization by coral or algae are included (the Sand category was removed).

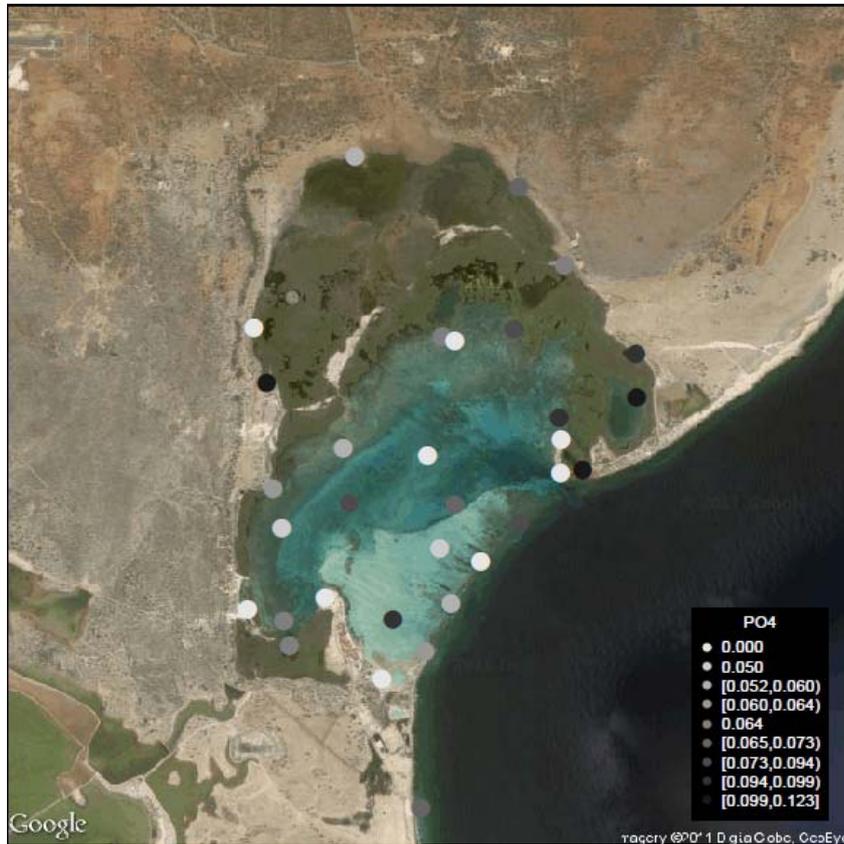
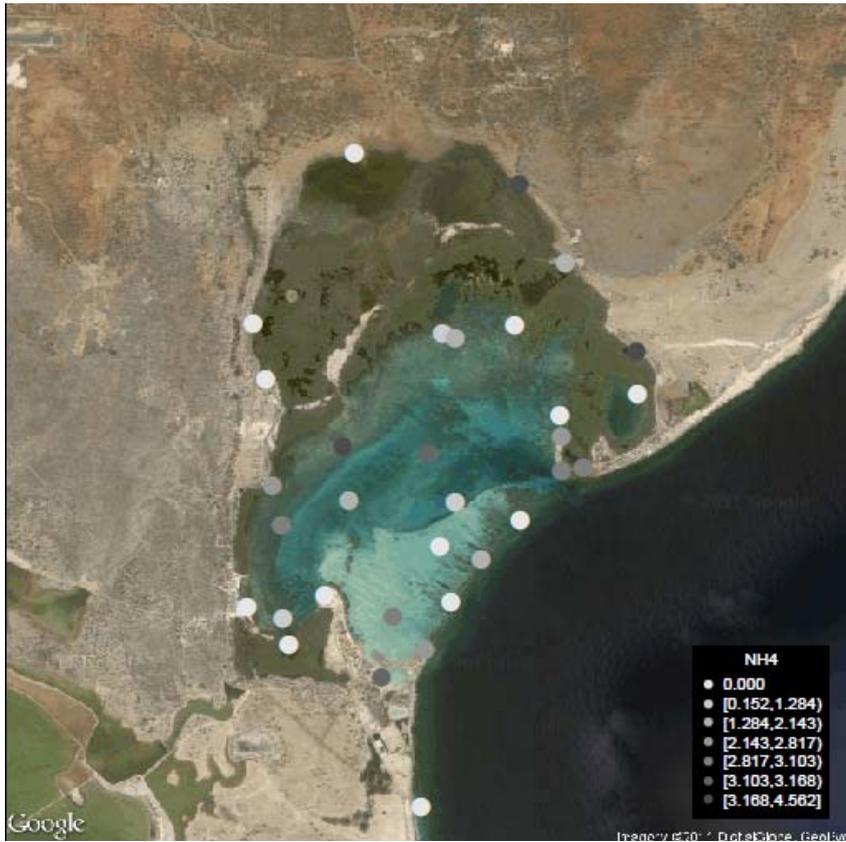
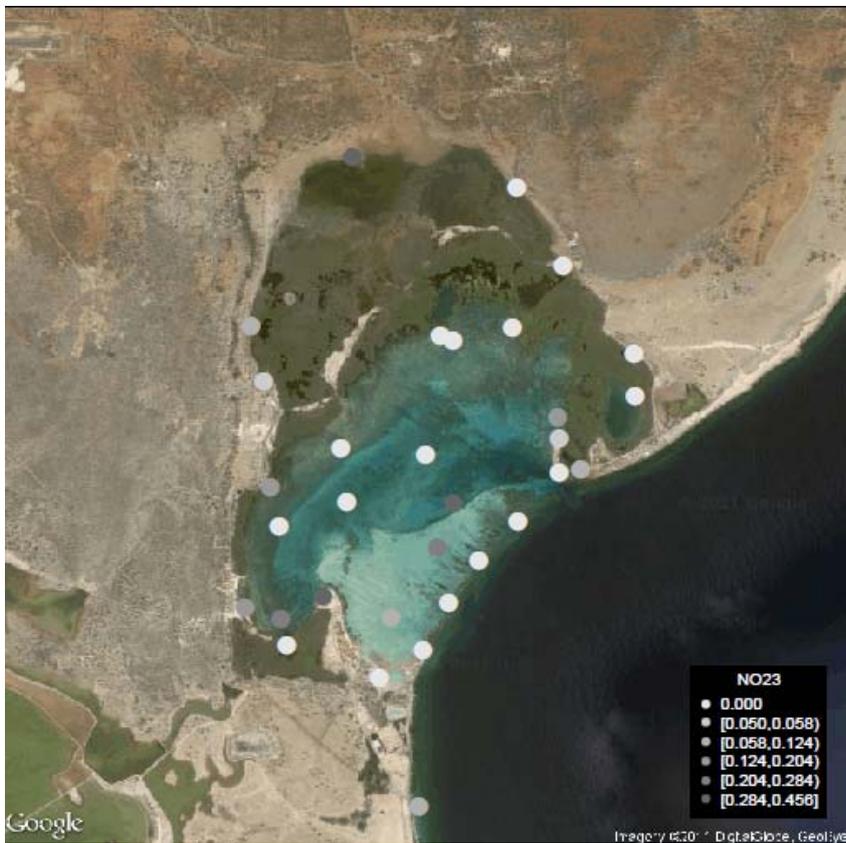
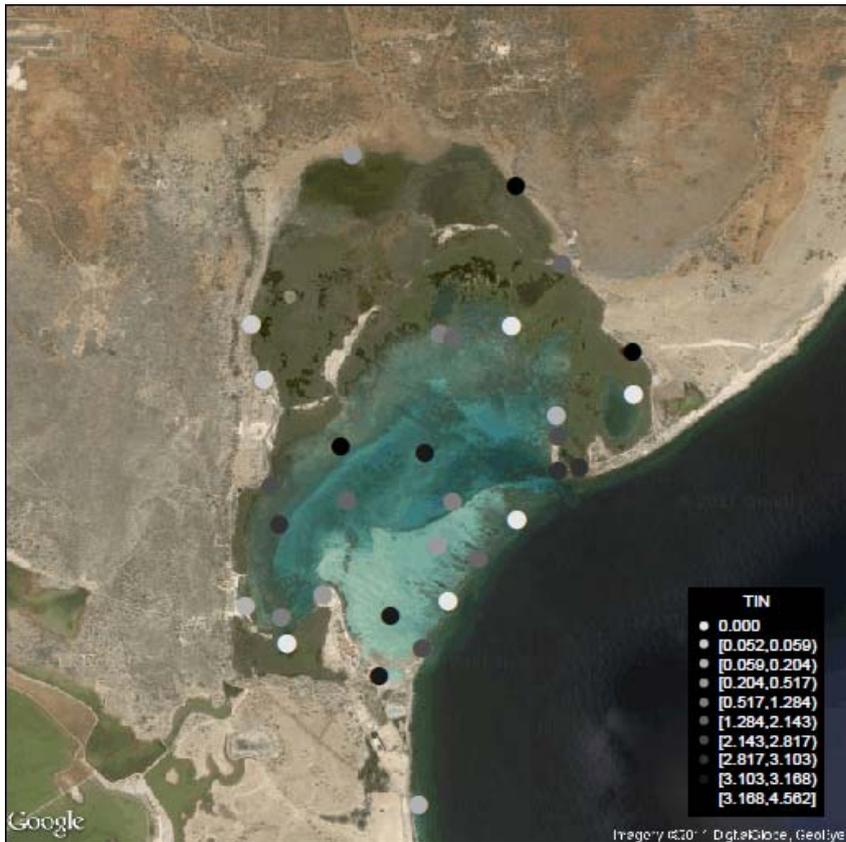
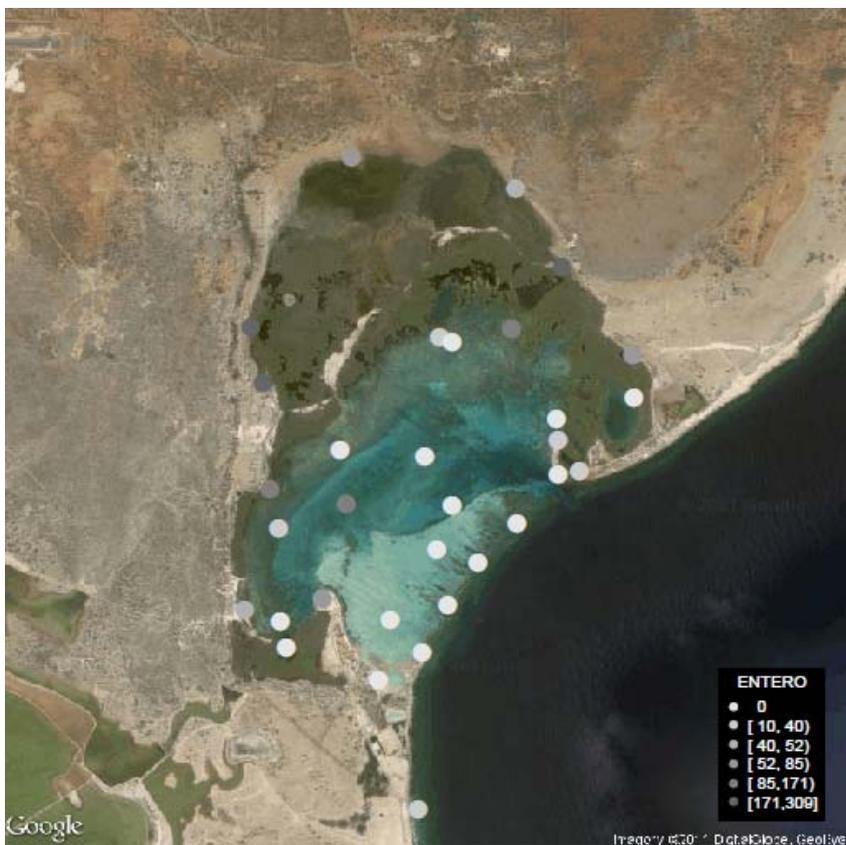
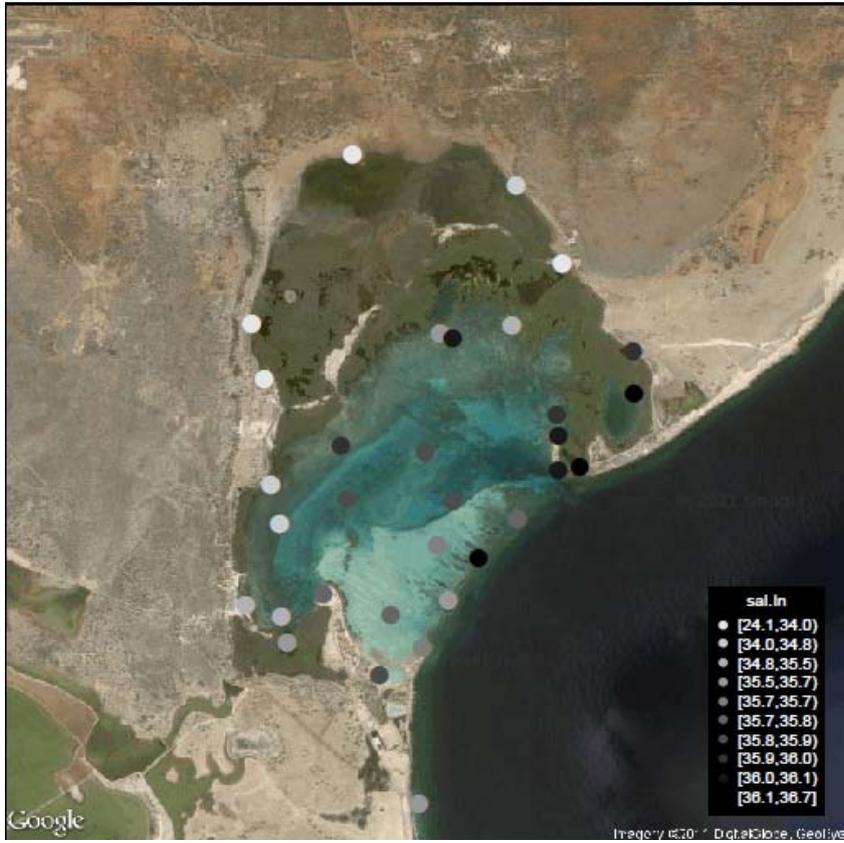
Overview of different parameters and concentrations at the visited locations in Lac during incoming tide

In appendix 3 nutrient concentrations are plotted in a geographical illustration of Lac. Figures presented in this appendix cover both incoming as outgoing tide illustrations.
