# Eutrophication status of Lac, Bonaire, Dutch Caribbean Including proposals for measures

Report number C093/11

## IMARES Wageningen UR

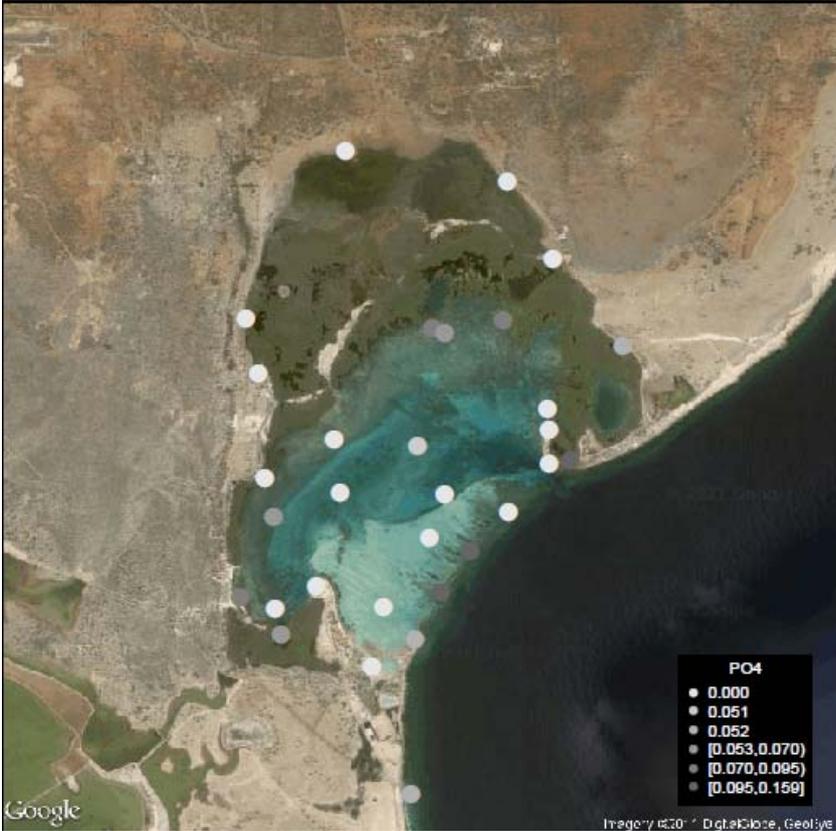
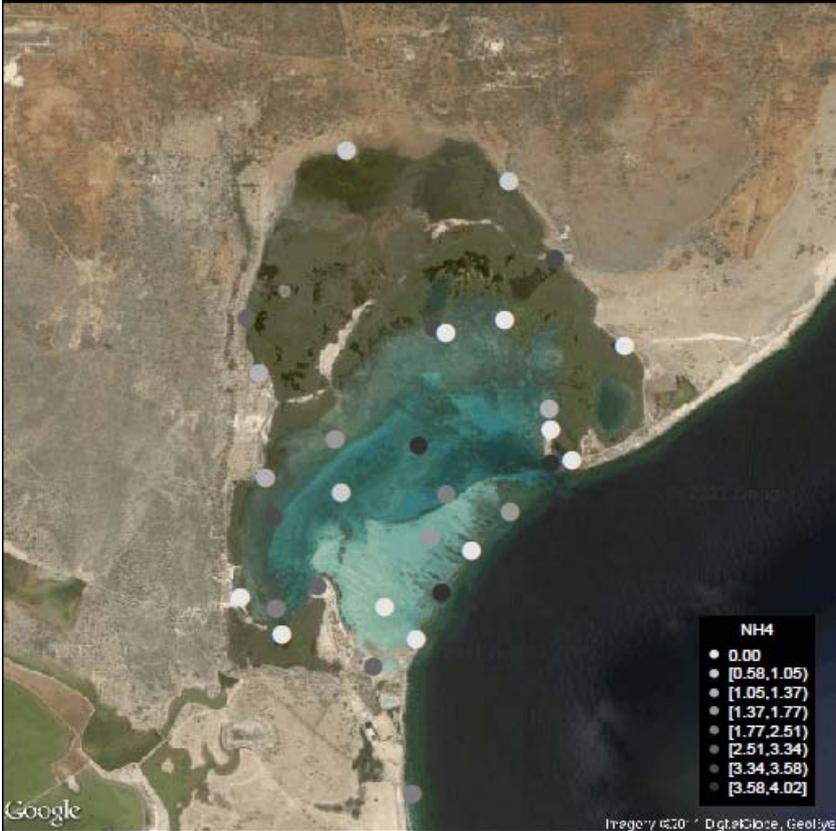
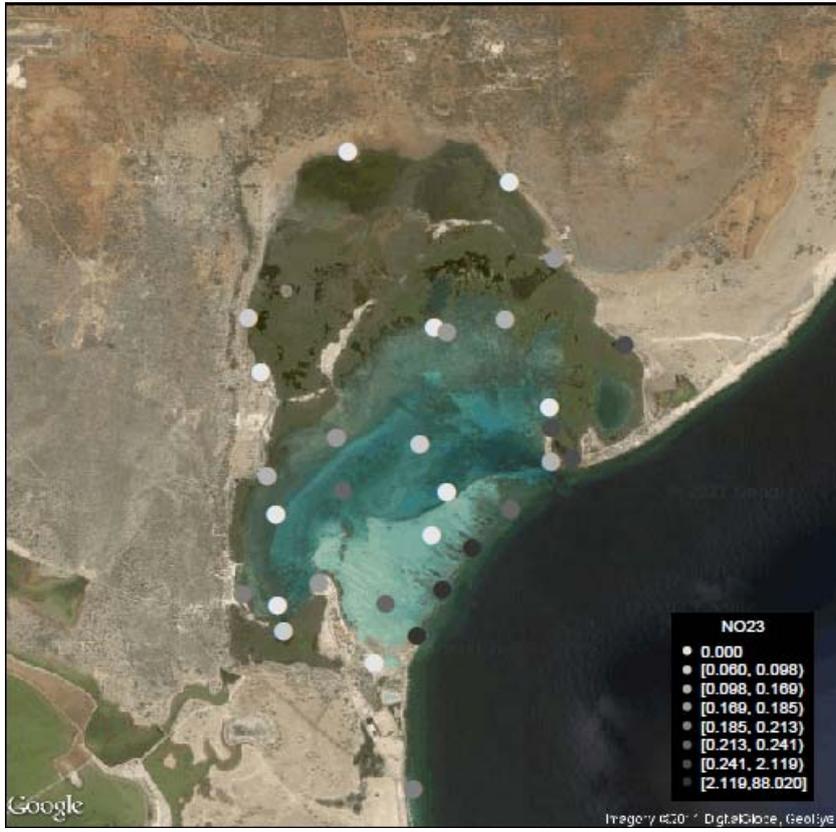
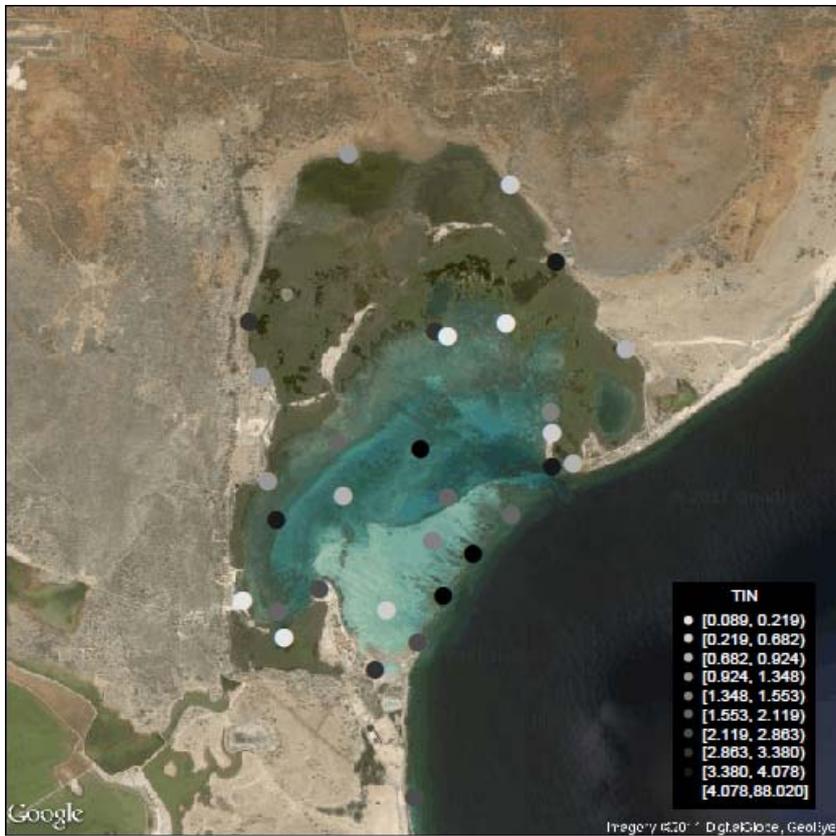
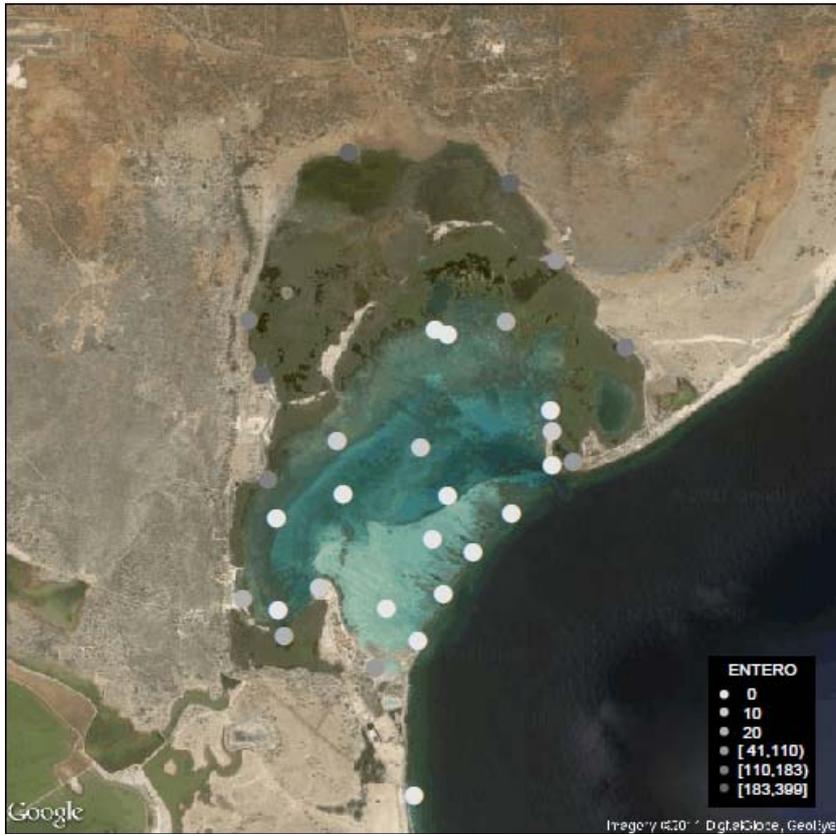
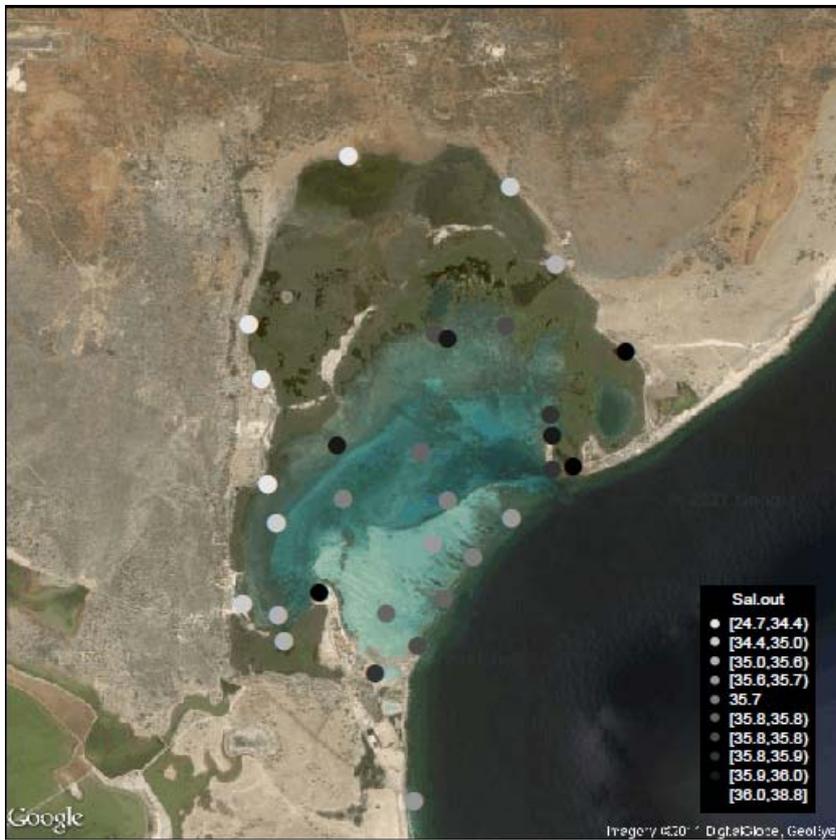
Overview of parameters and concentrations at the visited locations in Lac during outgoing tide.

In appendix 3 nutrient concentrations are plotted in a geographical illustration of Lac. Figures presented in this appendix cover both incoming as outgoing tide illustrations.
