Salinity and Sediment Issues in the backwaters of Mangrove Forests

Measuring of the Sediment Depths and Electrical Conductivity in the Mangrove Forests of Lac Bay, Bonaire

BSc thesis by < Rik van der Meulen >

Bachelor thesis Soil Physics and Land Management Group
submitted in partial fulfillment of the degree of Bachelor of Science
in International Land and Water Management at Wageningen
University, the Netherlands

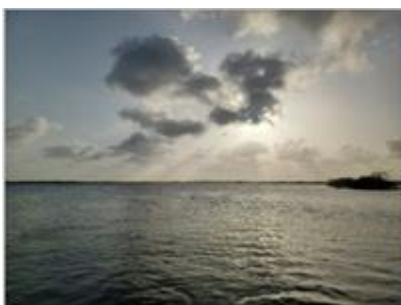
Figure 3a: Photo of Area 1.

Area 1 is an area which used to be covered with mangroves (*annex I*). Only some black mangrove trees remain together with some young trees of red mangroves in the most eastern part of the area. The waterbody of Area 1 is separated from the rest of the bay by mangrove forest and a few small islands (*figure 3a*). The area is 0,78 km².

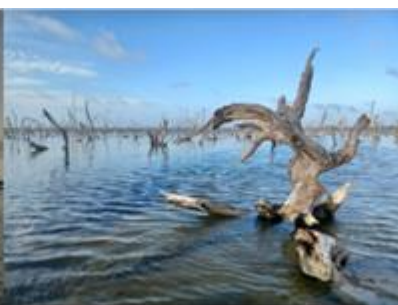
Figure 3b: Photo of Area 2.

Area 2 is an area where in the period of 2014-2020 a lot of mangrove trees died, which is visible in *annex XVIII*, and is characterized by dead trees, as is visible in *figure 3b*. Furthermore, the measured water depths did not exceed 0.65 meter and 122 out of 133 measured water depths in area 2 did not exceed 0,30 meter (*annex II*). The area is 0.16 km².

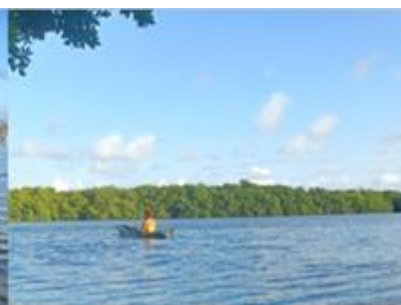
Figure 3c: Photo of Area 3.

Area 3 is a waterbody surrounded with red mangrove forests and is in direct contact with the rest of Lac Bay. The area is 0.056 km² and is used as the reference site for EC values of water which is surrounded with relatively healthy mangrove forests (*figure 3c*).

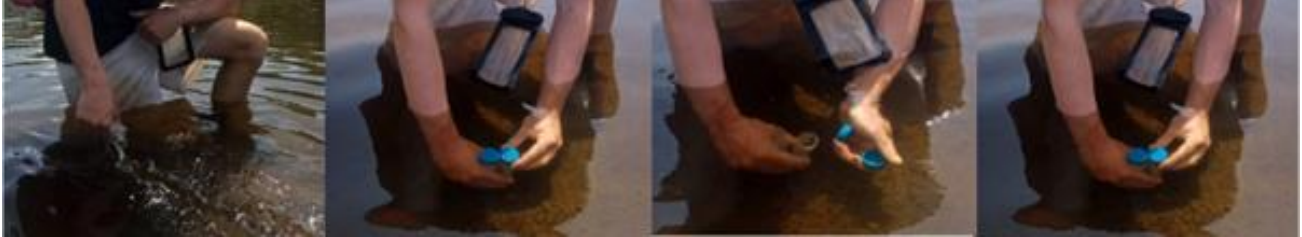
Figure 10A: Flushing

Figure 10B: Placing on sediments

The tubes used for water sampling have a volume measuring scale up to 50 ml. In addition, all individual tubes were marked with a unique number for later processing. To collect water samples a fixed procedure was followed, shown in figure 10.

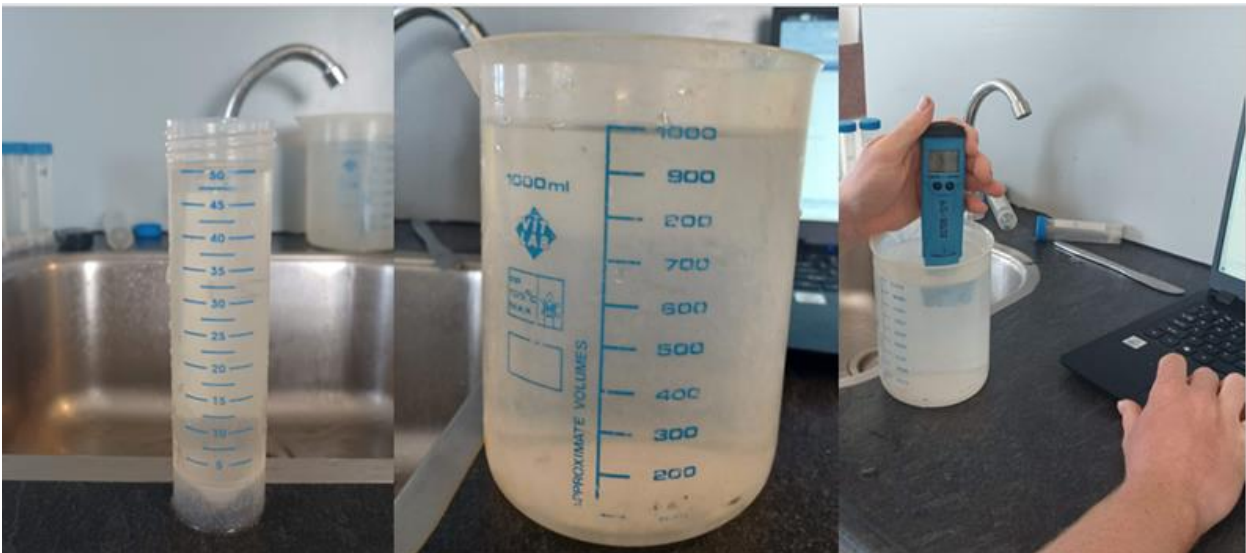
Figure 11A: Sample of 50 ml

Figure 11B: Dilution of sample

C: The EC value of the water is measured and noted down, together with the time the sample tube was taken in the field and the corresponding coordinates of the sample point (figure 11C).

After the collecting of the samples in step 1, the samples are diluted to measure the EC value. This was necessary as the used EC-meter (annex I) can only measure EC values up to 20.00 mS/cm. However, higher EC values were measured. The procedure of diluting the samples is shown in figure 11. Before the dilutions take place, the EC of the tapwater is also measured to know how much this affects the dilution.

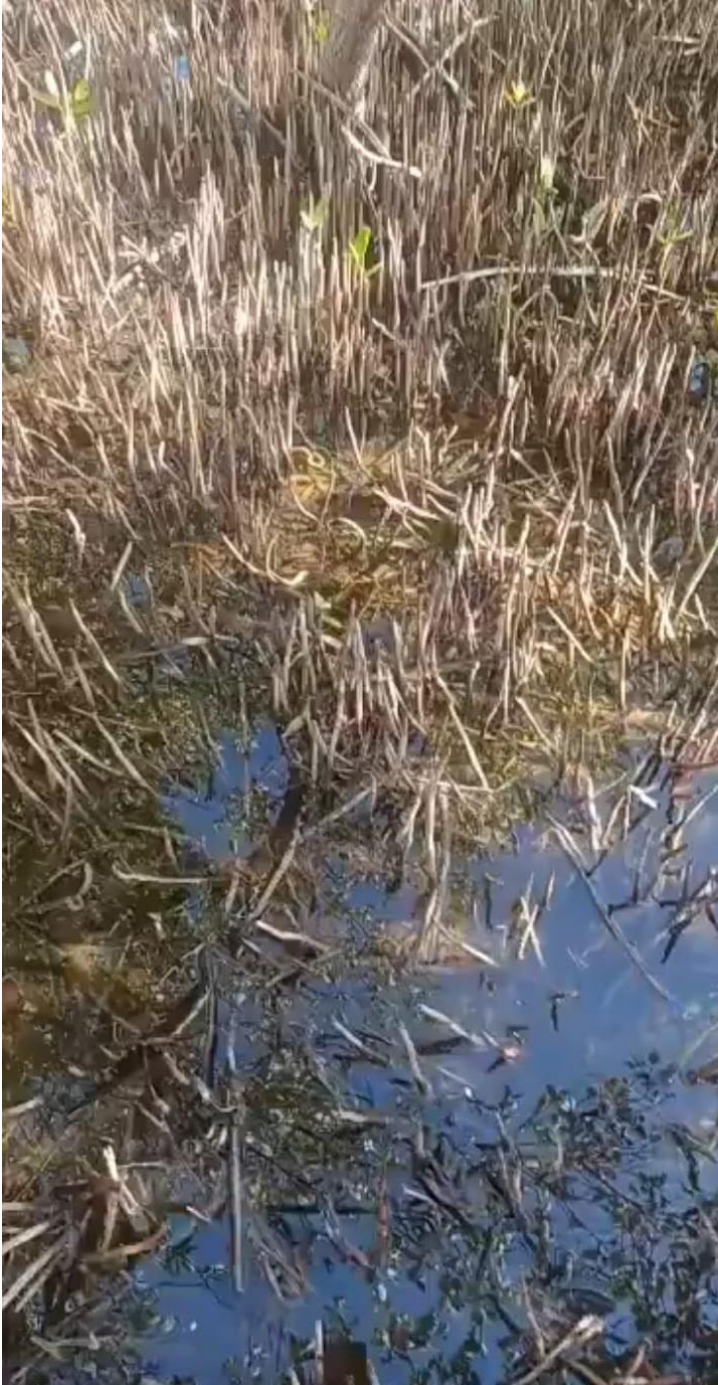
Figure 15: *High tide at the channel located at the southern border of Area 2.*

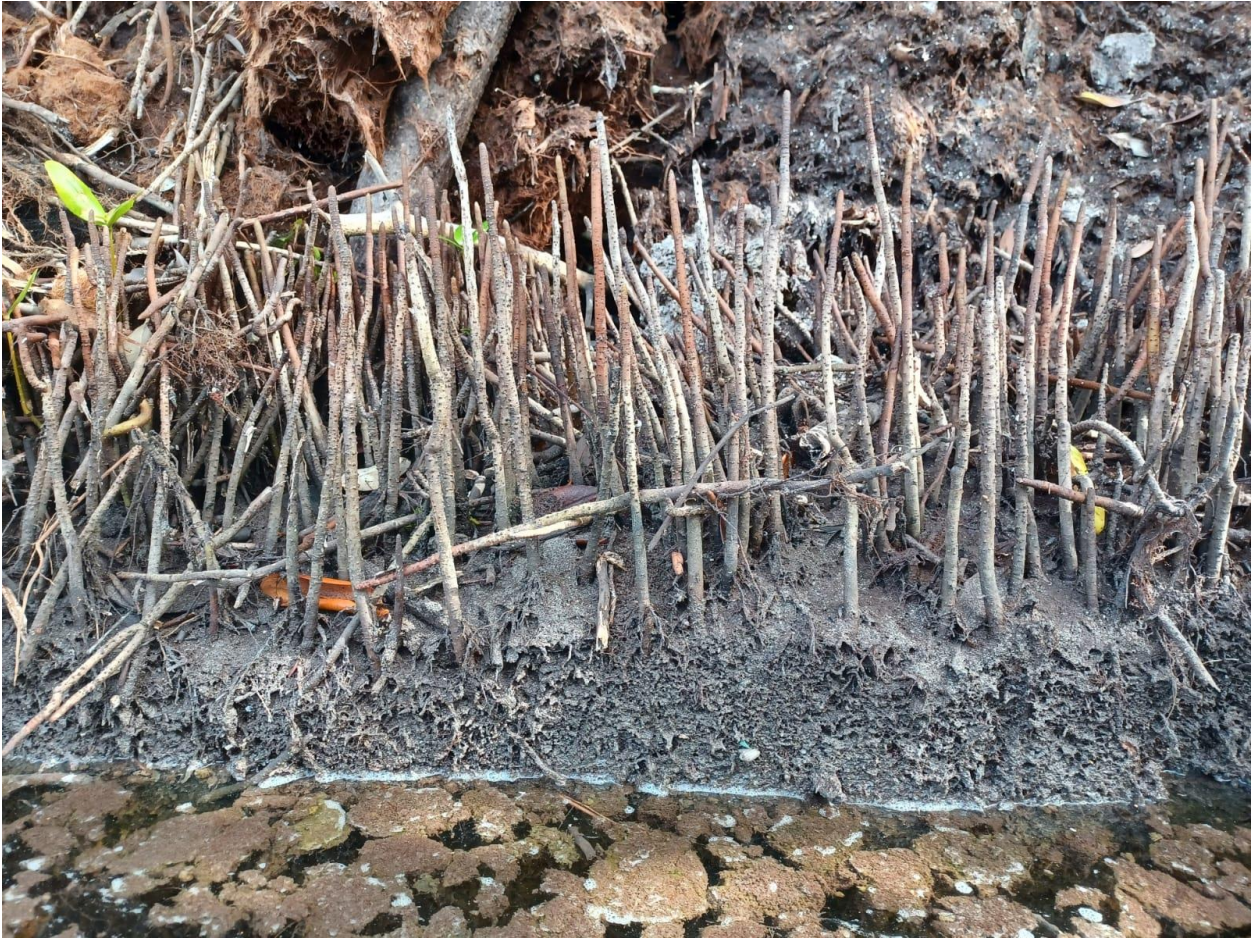
Figure 16: *Low tide at the channel located at the southern border of Area 2.*

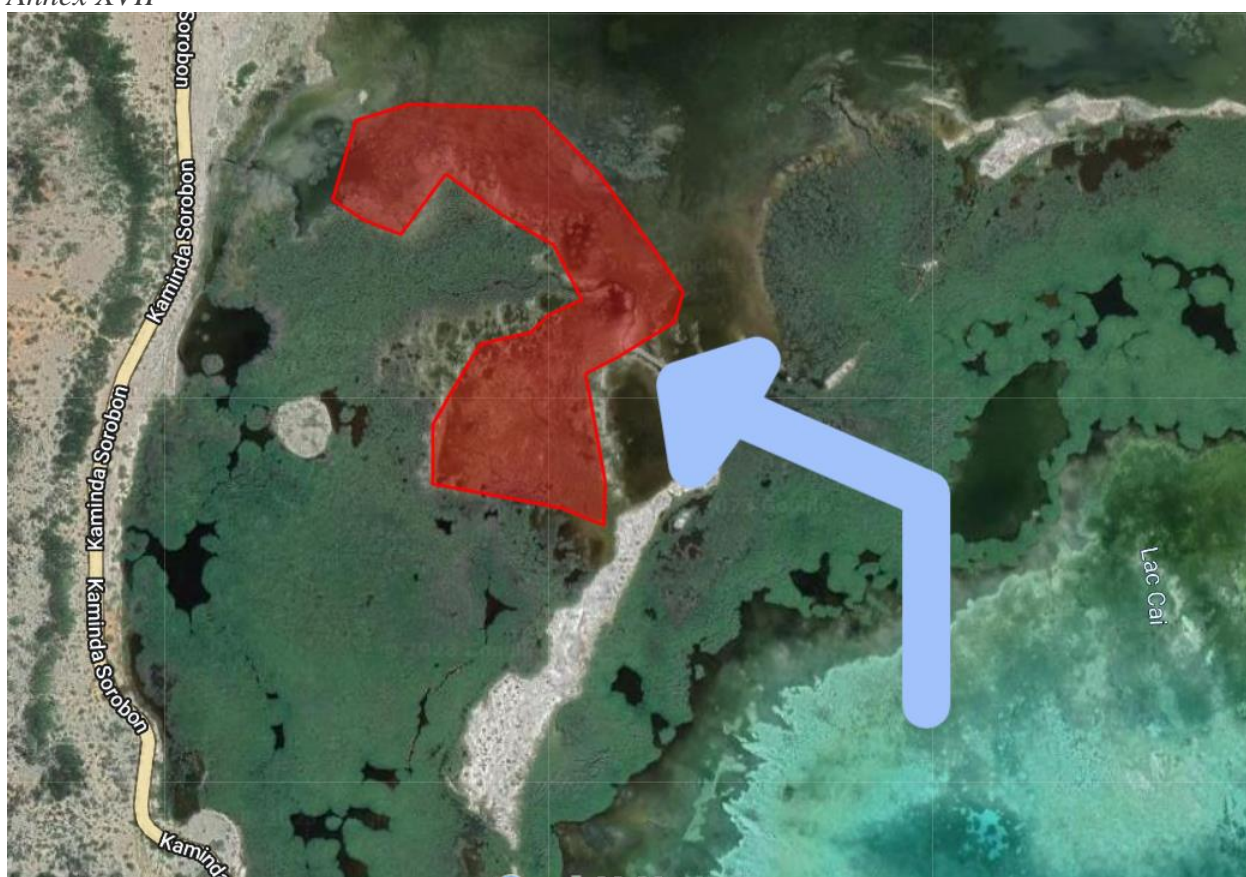
Figure 17: Possible water inflow from Lac Bay into the eastern part of Area 2. (google mymaps, 2023)
